SUBJECT SITE: Stratfield Elementary School
1407 Melville Avenue
Fairfield, CT 06825

INPSPECTION DATE: October 23, 2018

BIG EAST PROJECT #: 18591

LTD. LEAD BASED PAINT INSPECTION

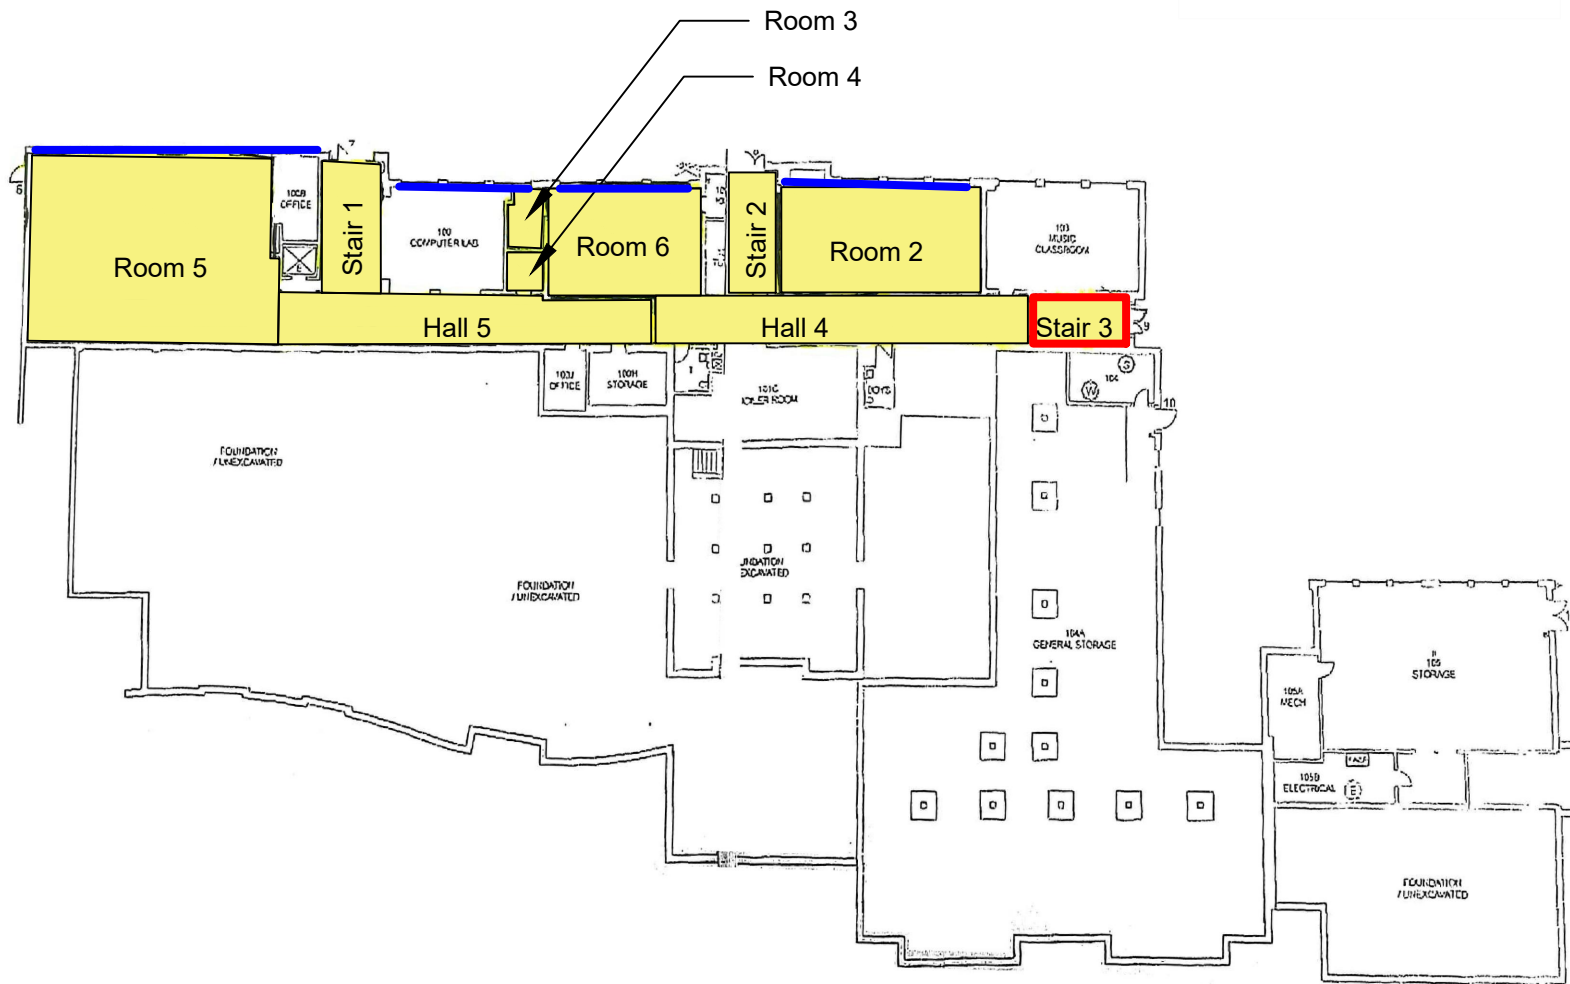
LEAD SURVEY - Basement

Room	Component	Side	Substrate	Condition	Color
Staircase 3	Wall	A	Brick	Intact	White
Staircase 3	Wall	B	Brick	Intact	White
Staircase 3	Wall	C	Brick	Intact	White

ID	LOCATION	SAMPLE AREA	RESULT	HUD Clearance Criteria
23	Room 5 - Window Trough	0.896 ft ²	3942 µg/ft ²	400 µg/ft ²
26	Room 6 – Window Trough	1.000 ft ²	1890 µg/ft ²	400 µg/ft ²

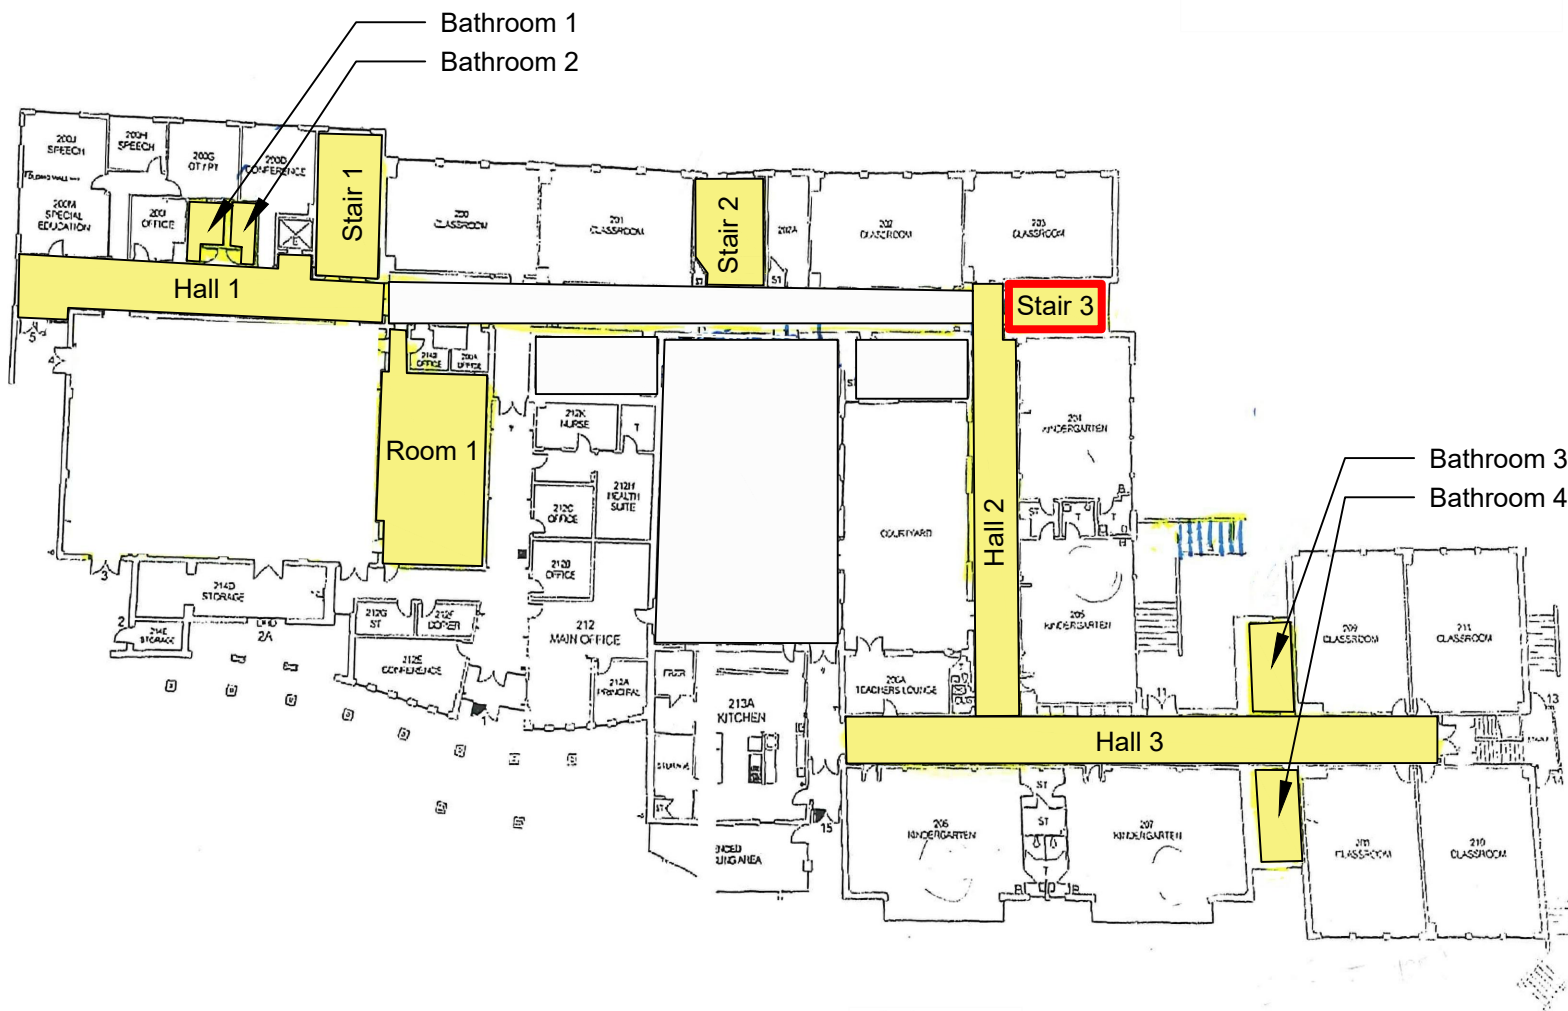
LEAD SURVEY - 1st Floor

ROOM	COMPONENT	SIDE	SUBSTRATE	CONDITION	COLOR
Staircase 3	Wall	A	Brick	Intact	White
Staircase 3	Wall	B	Brick	Intact	White
Staircase 3	Wall	C	Brick	Intact	White

ID	LOCATION	SAMPLE AREA	RESULT	HUD Clearance Criteria
23	Room 5 - Window Trough	0.896 ft ²	3942 µg/ft ²	400 µg/ft ²
26	Room 6 - Window Trough	1.000 ft ²	1890 µg/ft ²	400 µg/ft ²
