Re: Feasibility Study - Interior PCB Containing Paints  
Fairfield Ludlowe High School, Fairfield, Connecticut

## FEASIBILITY STUDY

Interior PCB Containing  
Paints

Fairfield Ludlowe High  
School, Fairfield, CT

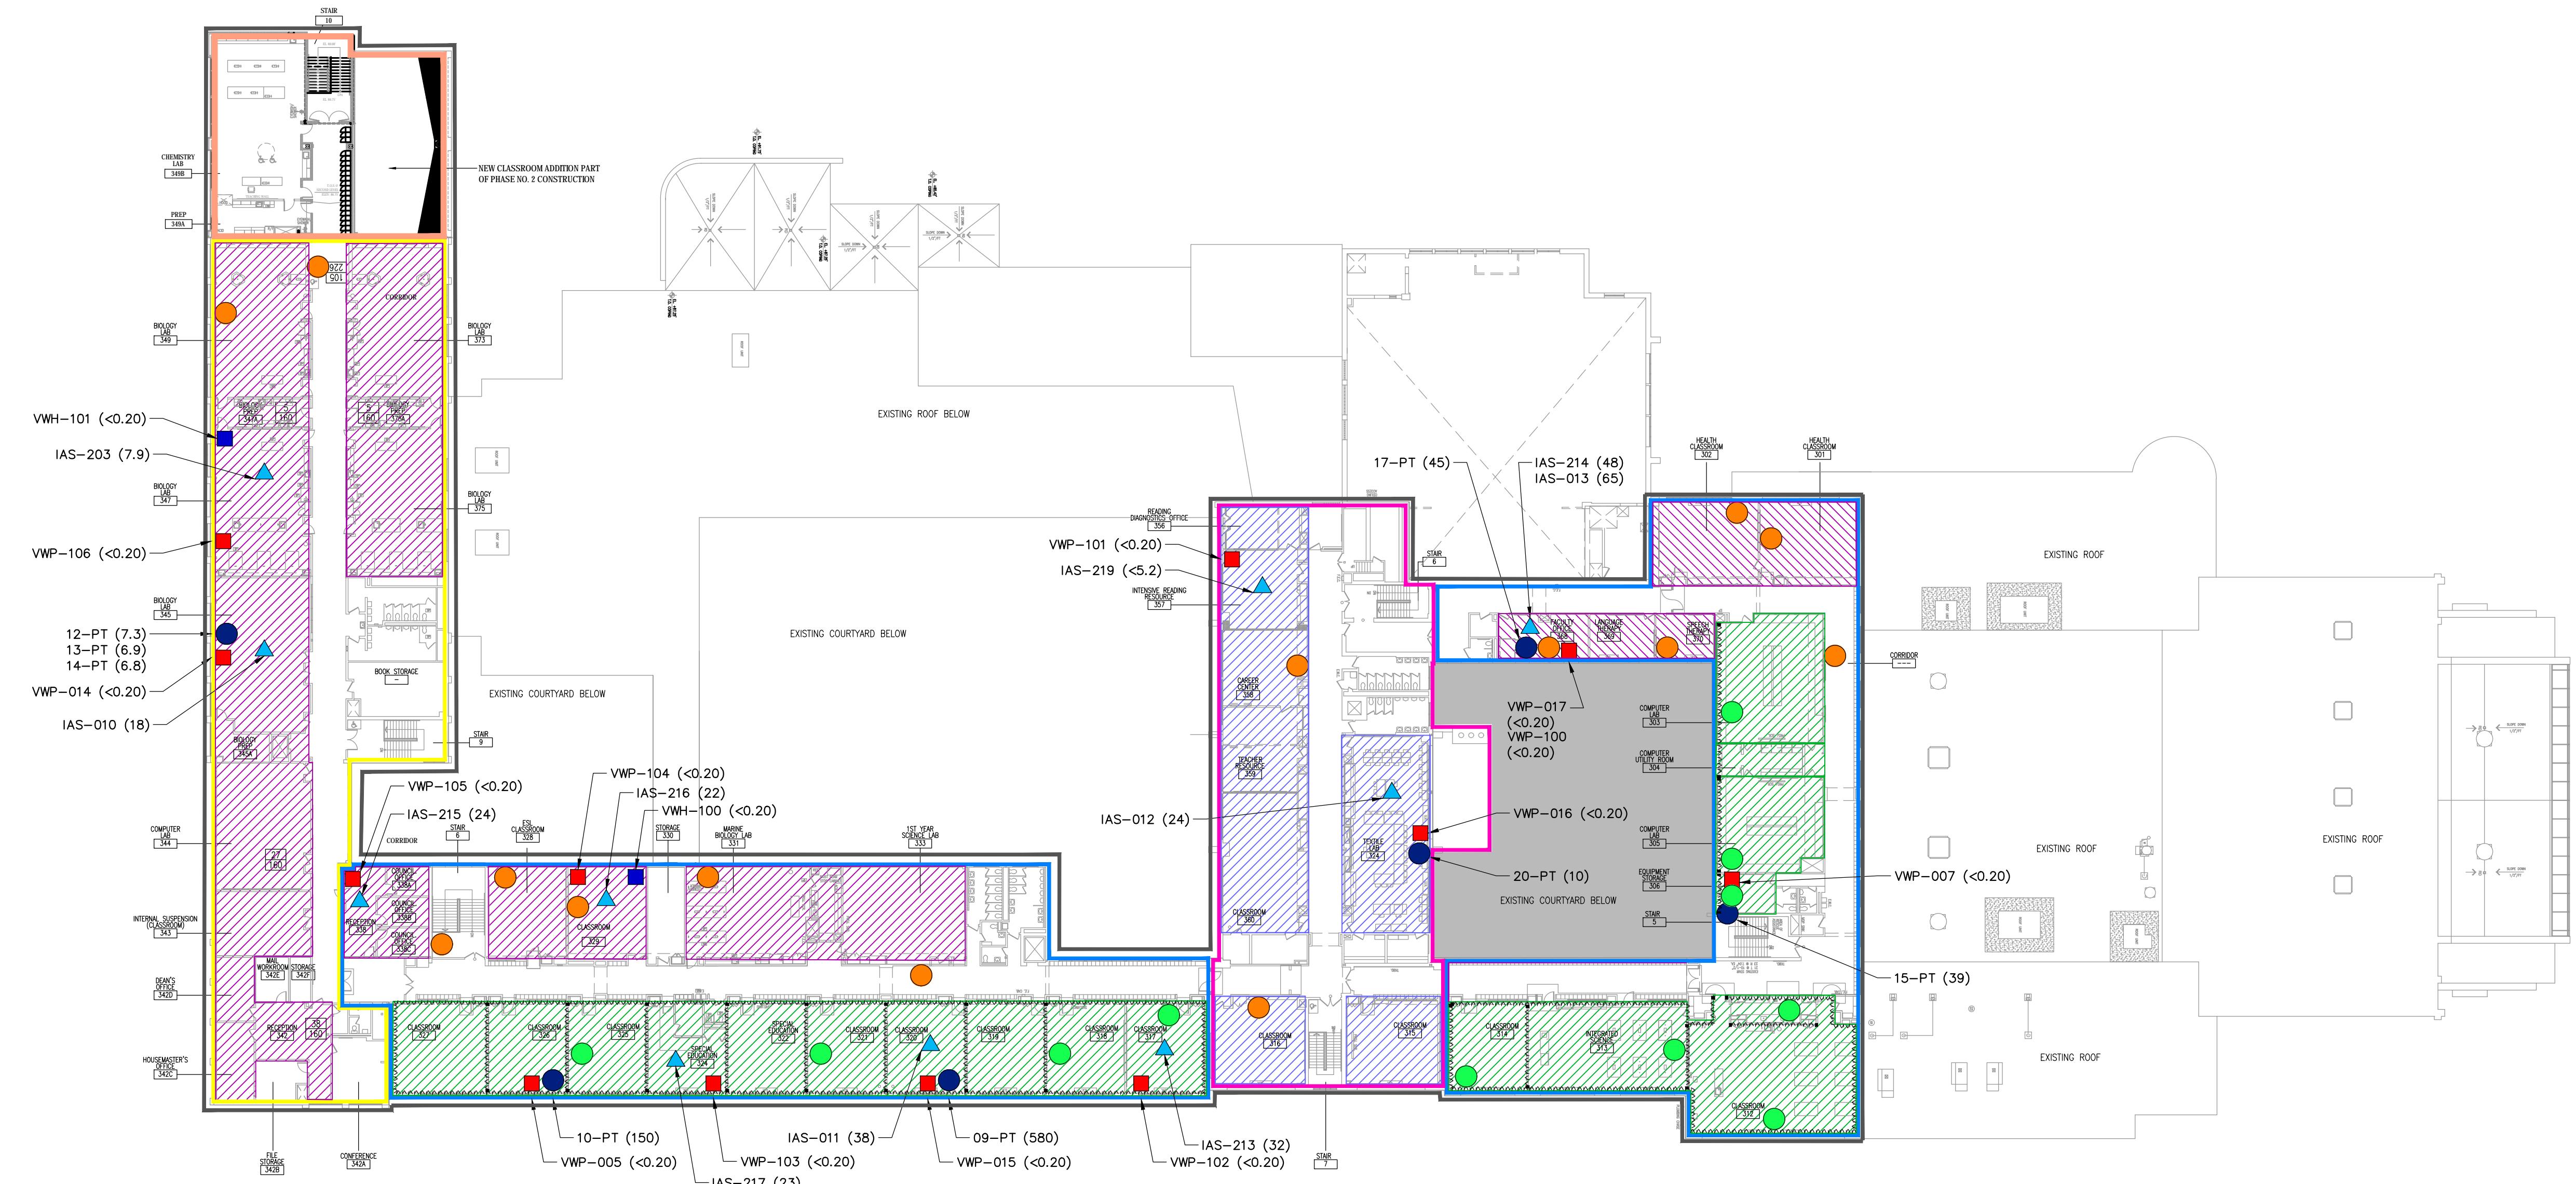
# FIG. 1

In summary, a pale green paint was observed beneath the top coat(s) of paint on CMU block walls within the majority of the perimeter rooms of the first, second, and third floors of the 1961/62 portions of the building and it is presumed that this paint was manufactured with  $\geq 50$  ppm PCBs. This pale green paint was not observed in other areas of the 1961/62 construction area nor was it observed in any portion of the building constructed in 1950 or in 1971/72. Also of note, this pale green paint was only observed beneath an existing paint (i.e., it was not observed on any accessible painted walls/surfaces). PCB concentrations  $< 50$  ppm were reported in paints located in the 1971/72 and 1950 portions of the building.

**LOCATION OF PALE GREEN PAINT OBSERVED BENEATH OUTER PAINT LAYERS**
