December 17, 2018

RE: Indoor Air Quality Screening and Consulting Support Services
Holland Hill Elementary School

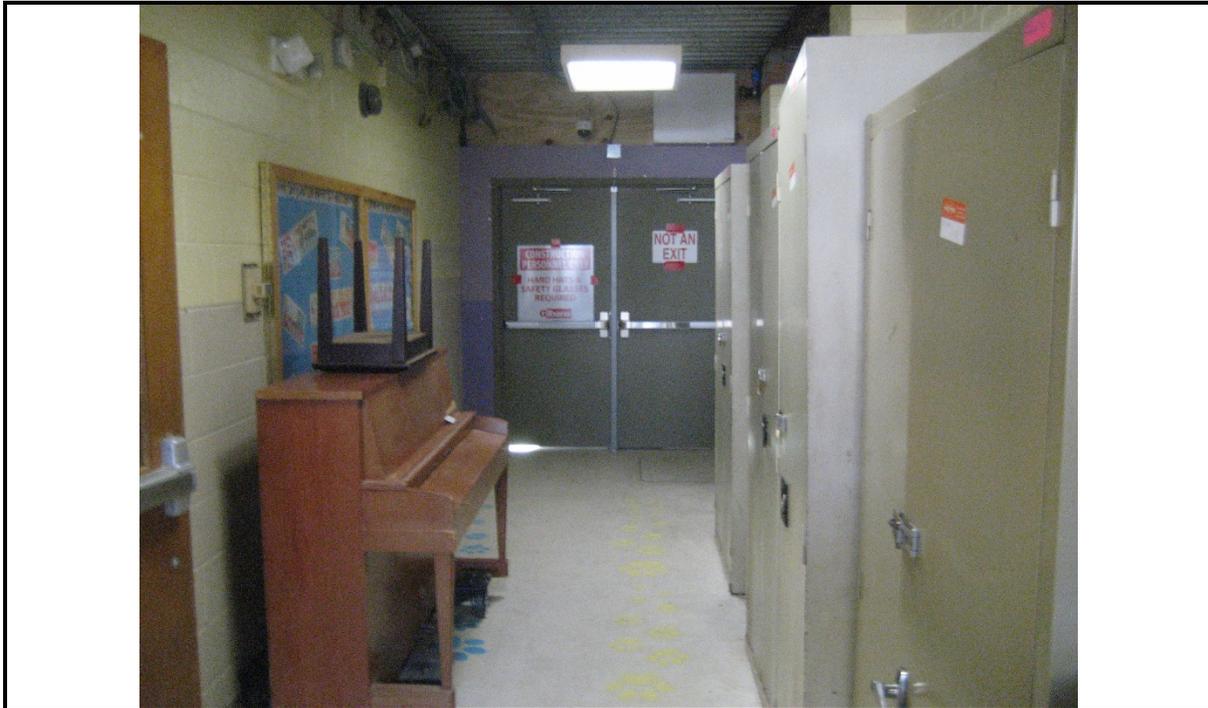
Photo Number: 1

The airborne particulate concentrations in the typically occupied classrooms were generally within the guidelines recommended by the US EPA NAAQS. Areas in the corridor outside the gymnasium and corridor outside the library were higher as compared to the occupied areas of the school and were greater than recommended indoor air quality levels. The recommended IAQ levels are 24-hour averages that were compared to the measured concentrations in the school. The levels of particulate in these areas were likely drawn in from the south construction area, where higher concentrations of airborne particulate were measured.

Description: Entrance to construction, corridor outside gymnasium

- Construct a temporary wall should be between the occupied areas of the school and the construction areas. This wall should be constructed to separate the two areas and should extend from floor to ceiling.

- Minimize passage between construction and occupied areas.
- Construct an anteroom around the doors to minimize the migration of particulates and odors.

- Maintain the doors in a closed position and maintain sweeps and gaskets to maintain tight seal. Maintain the construction area at a negative pressure differential relative to the adjacent occupied areas. Air filtering devices equipped with HEPA filters can help control air flow. Filtered air should be exhausted to the outdoors away from windows, doors and pedestrian walkways. A differential pressure gauge or manometer can show the difference in pressure between the work and occupied areas. Dust mitigation techniques such as local exhaust ventilation with High Efficiency Particulate Air (HEPA) shrouded tools or the use of water will capture or minimize dusts as they are generated.

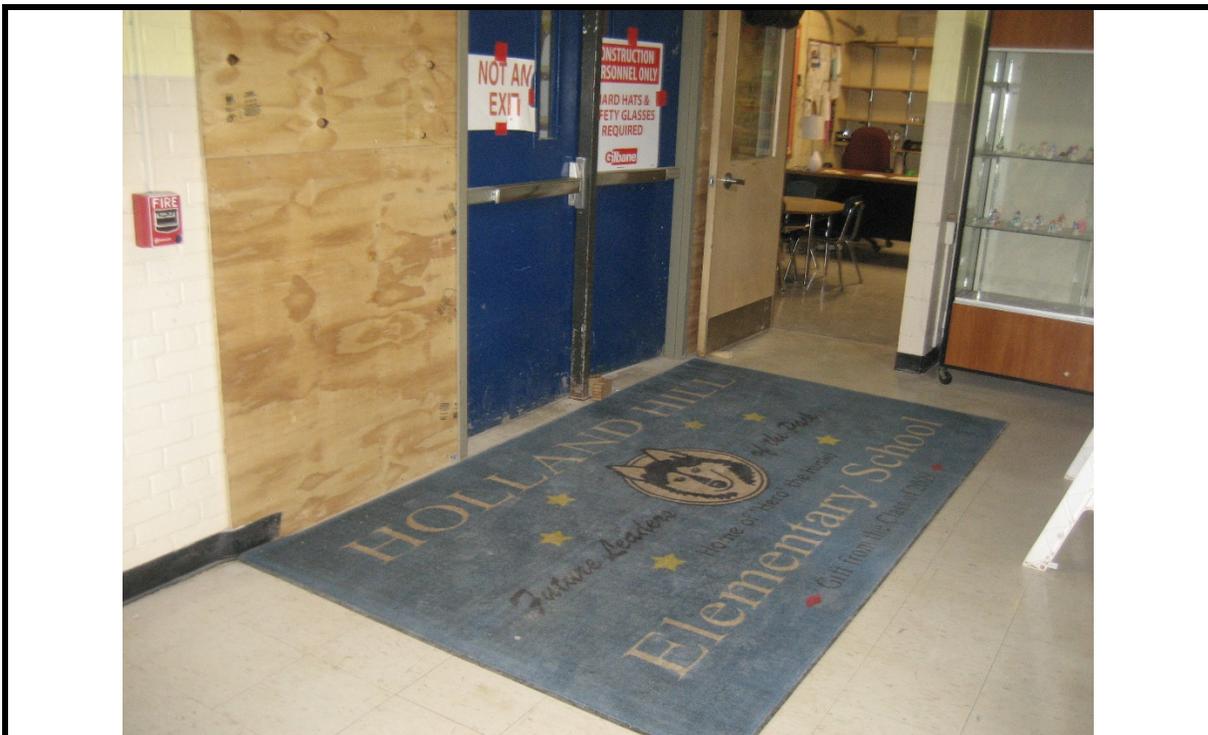
Photo Number: 2

Description: Entrance to construction, vestibule outside Library

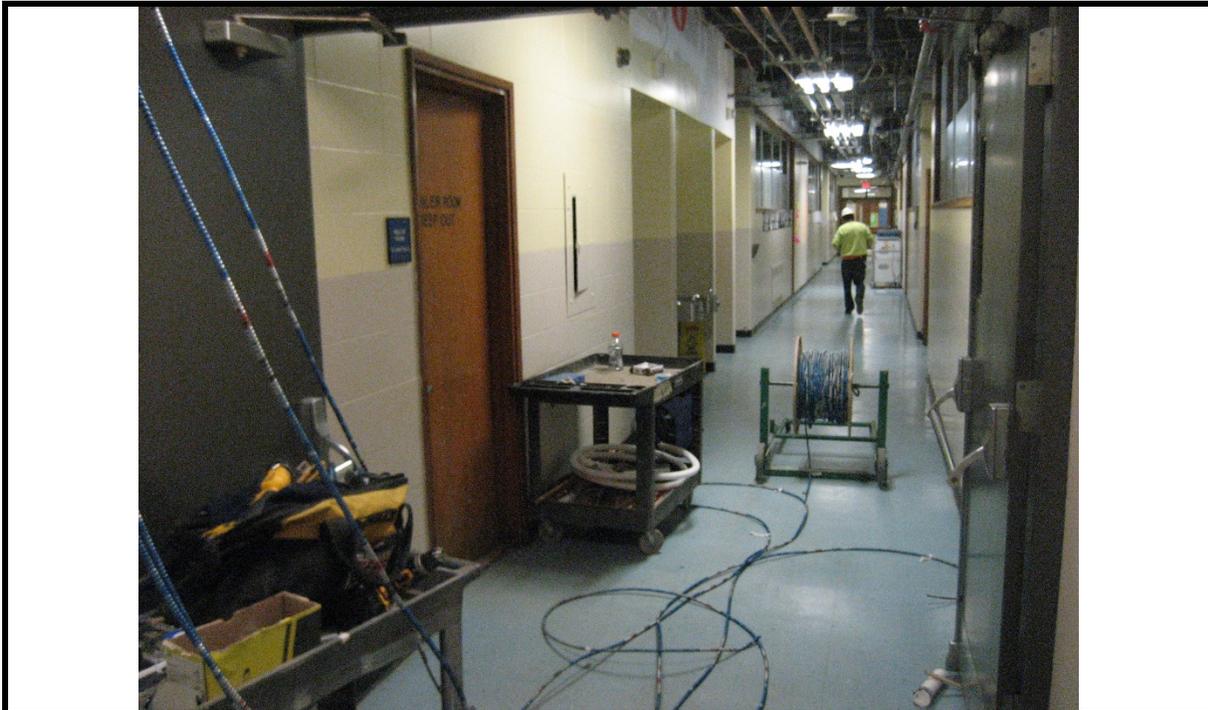
Photo Number: 3

On the day of the site visit, an electrical subcontractor was installing wires above the suspended ceiling grids in the existing classrooms and corridor outside classrooms 12 and 14 and in the boiler room. Wiring was also being installed in the south construction area. Approximately 10 people were working on the day of the site visit. No other subcontractors were observed conducting construction-related activities during the site visit.

At the door to the Boiler Room, air was observed flowing into the Boiler Room.

Description: Corridor outside Boiler Room, wires being installed above ceiling

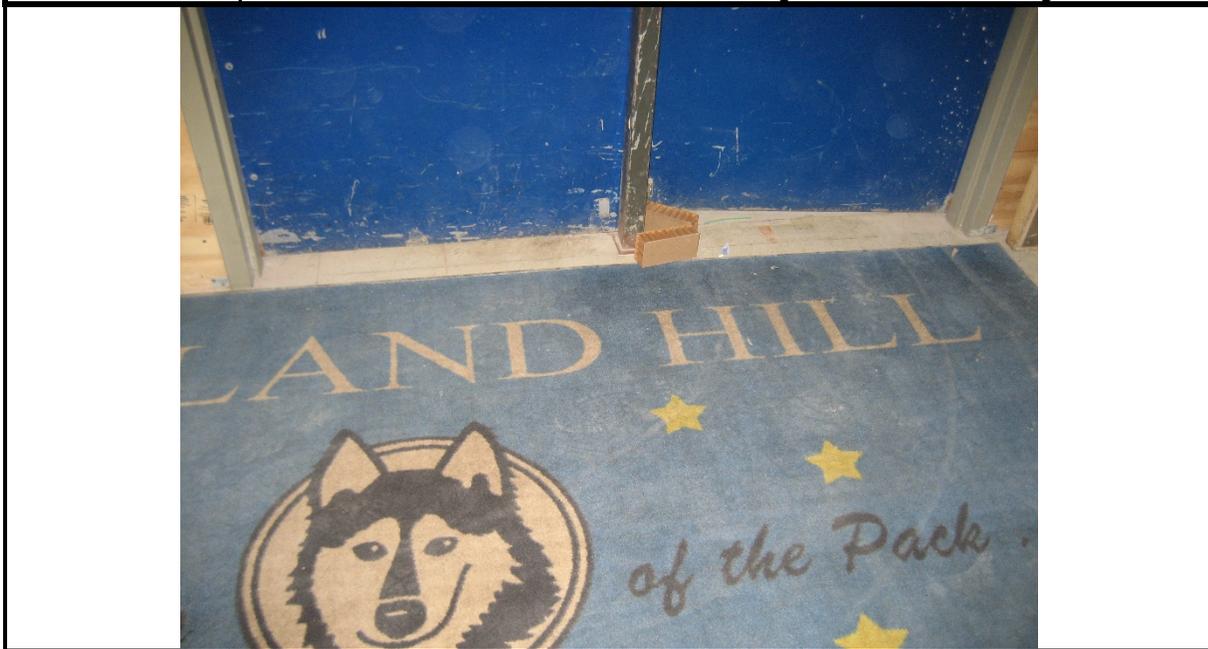
Photo Number: 4

Description: Entrance to construction area, carpet

Outside the construction zone, sticky mats could be placed to collect dust from the bottom of work boots as workers leave the construction zones and enter the school. These mats should be changed frequently. The areas around the entrance to construction should also be cleaned with vacuum equipped with a HEPA filter and mopped frequently. A log should be kept and displayed to indicate when cleanings occur.

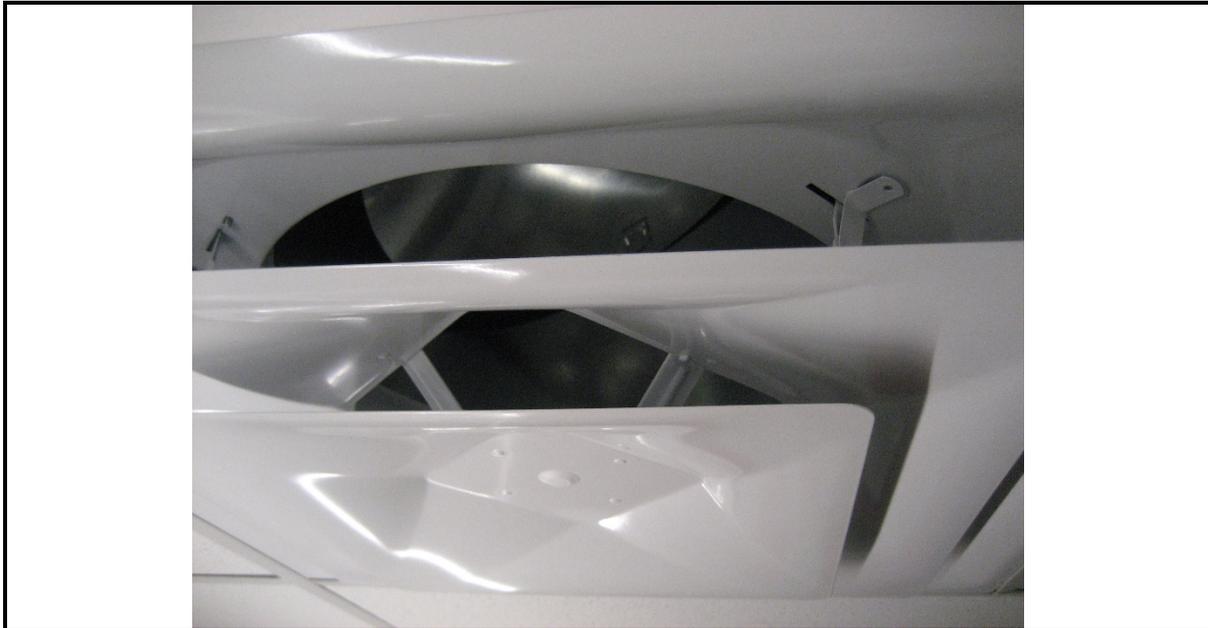
Photo Number: 5

Although Woodard & Curran did not have access within the HVAC ducts at the time of our assessment, or to the rooftop air handling units, the supply air diffusers in the library were observed. They appeared clean as did the area above the acoustical ceiling tiles. The other areas of the currently occupied areas of the school do not currently have mechanical HVAC. The supply air ducts and diffusers in the gymnasium were approximately 25 to 30 feet above floor level and could not be inspected.

Description: Library, supply air diffusers

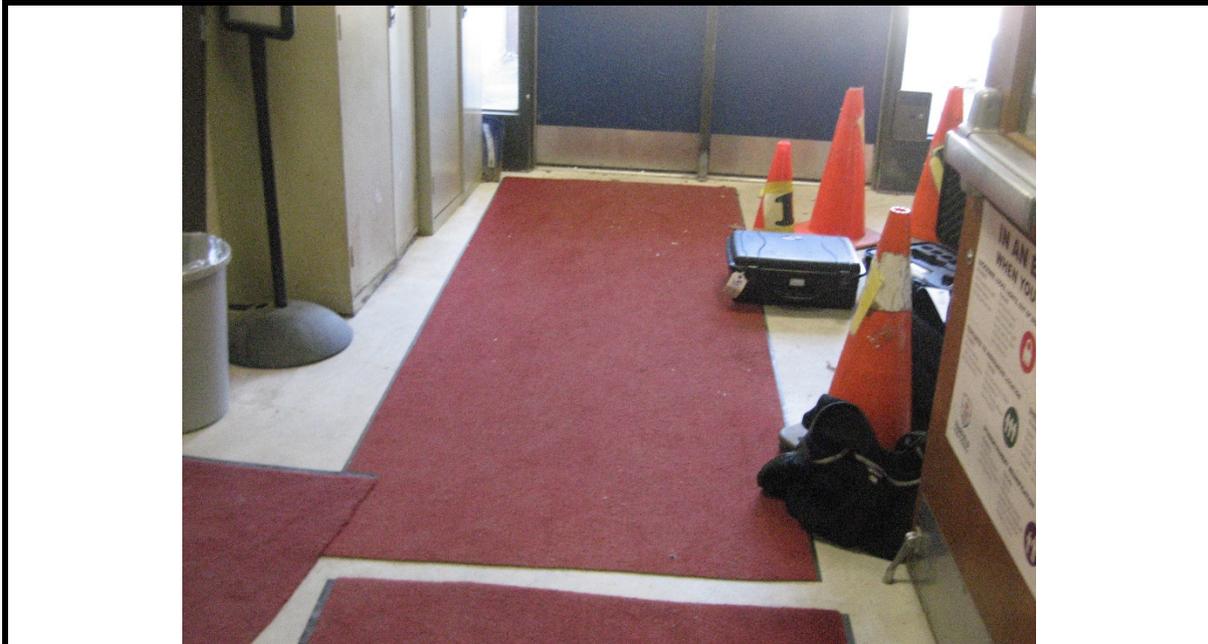
Photo Number: 6

Description: Corridor outside gymnasium

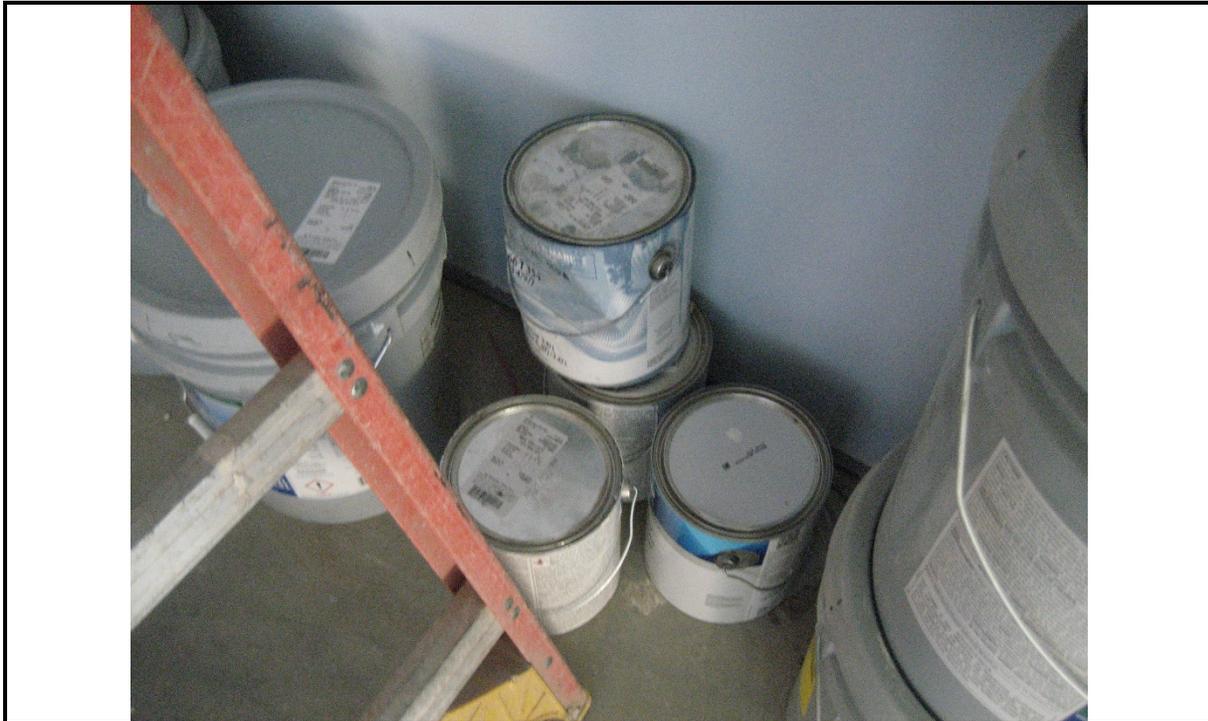
Photo Number: 7

The concentration of VOCs was measured higher in the south construction area compared to the occupied classroom area. Five-gallon cans of paint and primer were stored in the corridor of the south construction area and could be the source of VOCs measured in the school. A janitor's closet with various cleaning products was observed during the survey.

Description: Paints stored in south construction area
