# Hazardous Materials Survey Report

Holland Hill  
Elementary School

105 Meadowcroft Road  
Fairfield, Connecticut

230299  
**Kenneth Boroson**  
**Architects**  
March 2017

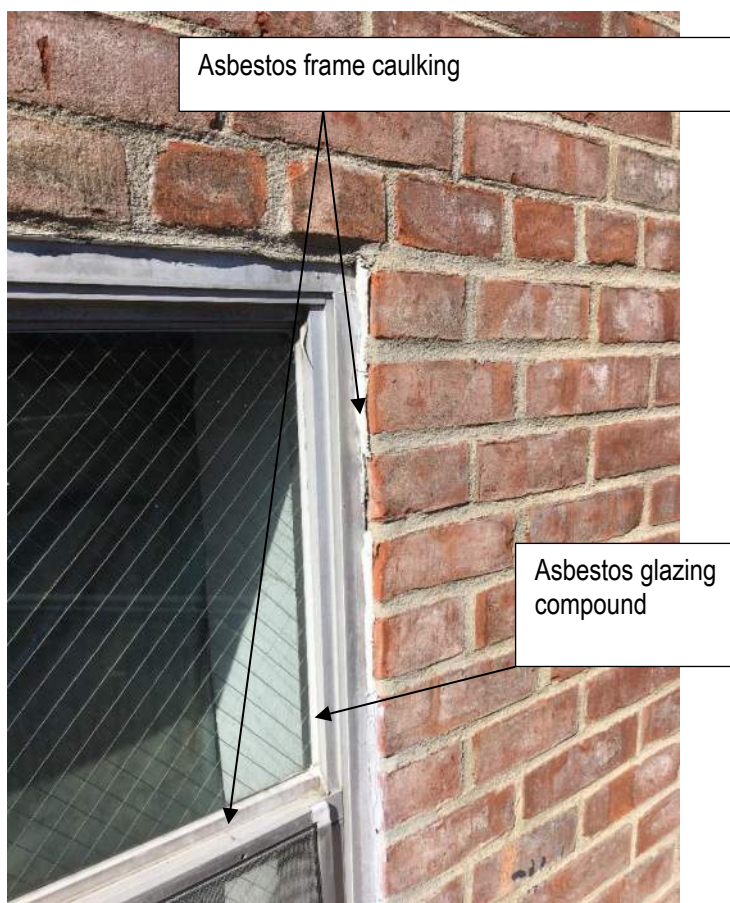
**Window Sealants** – The window glazing compound, and the window frame caulking associated with the single paned building perimeter windows were identified as an ACBM. In addition, glazing sealants associated with the two double doors on the south side of the building were identified as ACBM (caulking sealants on those doors were not).

The sealants appeared to be in good to fair condition and are not friable. Based on the renovation scope of work, the single paned windows at the office/administrative area and the restrooms in the east wing of the 1956 portion of the building are scheduled to be replaced. The same sealants were also observed on the kitchen windows and the clerestory windows in the all-purpose room and stage area which are not currently scheduled for removal but may be addressed through re-caulking. Finally, the two double doors on the south side of the building are to be replaced according to the existing renovation scope.

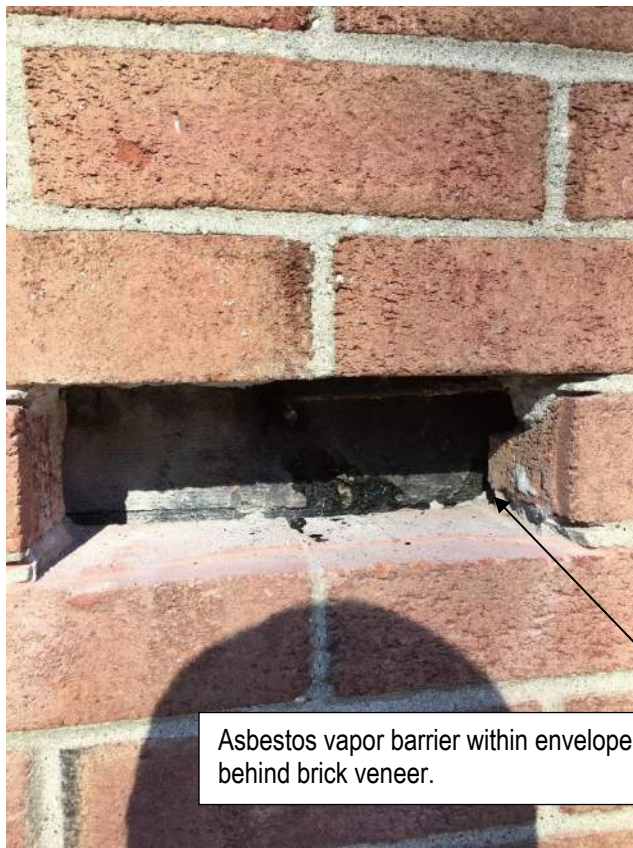
**Vapor Barrier Within Envelope Walls** – An asphaltic vapor barrier system comprised of asphaltic paper and associated asphaltic mastic / adhesive is present within all building envelope walls where inspection was conducted. These materials, including the paper and the mastic / adhesive, have been identified as ACBMs. These materials are in good condition where observed and are not friable. Approximately 800 square feet of this material would likely be disturbed by demolition of the bathrooms next to the gymnasium. Approximately 50 square feet may be disturbed by the installation of a new doorway in the gymnasium envelope wall. It is not clear how much, if any of this material would be disturbed by the replacement of windows.

Asbestos vapor barrier within envelope wall behind brick veneer.

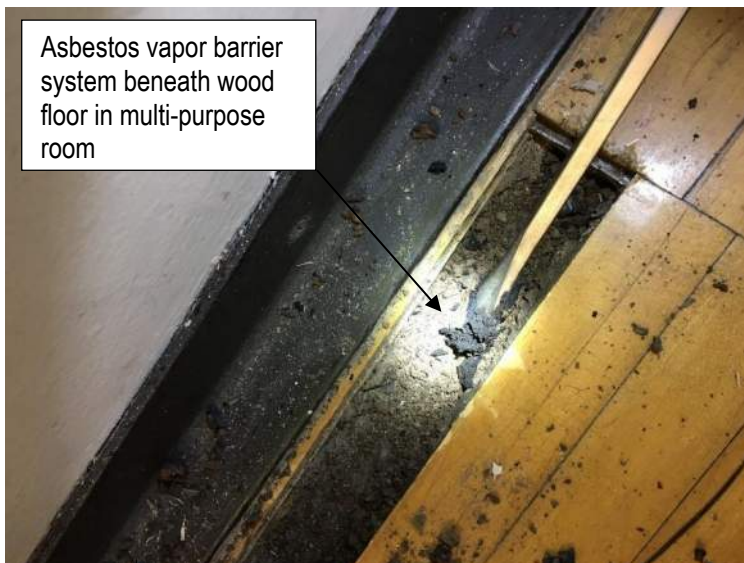
**Vapor Barrier Beneath Wood Flooring** – A black asphaltic vapor barrier system including asphaltic mastic and asphaltic paper that is present beneath the wood floor in the multi-purpose room was identified as an ACBM. This vapor barrier system is applied to the concrete floor of the room and is present beneath wood finish flooring and cork sub-flooring. The vapor barrier is non-friable and appeared to be in good condition where observed. Approximately 3,000 square feet of this material is estimated to be present beneath the finish floor in the multi-purpose room.

Asbestos vapor barrier system beneath wood floor in multi-purpose room

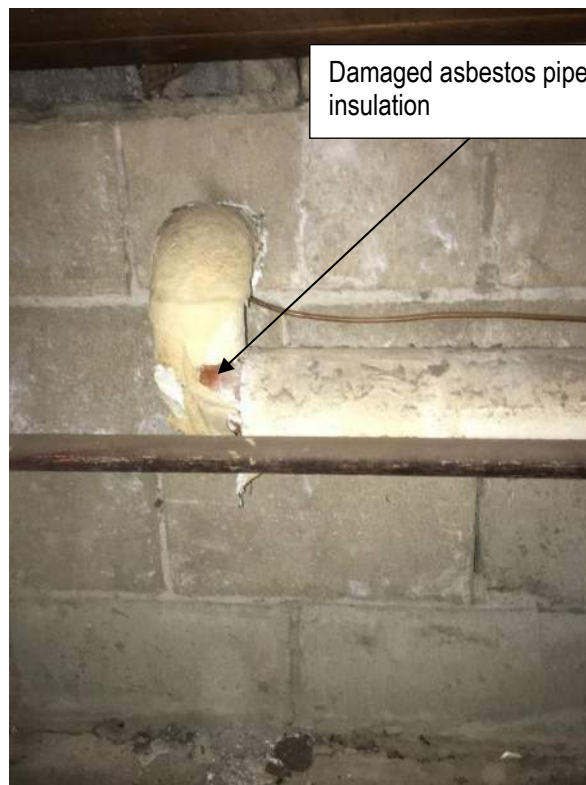
**Pipe Insulation** – The insulation on heat and domestic water pipes observed in various areas of the building scheduled for renovations has been identified as ACM. The asbestos pipe insulation was observed beneath the stage in the multi-purpose room, above the stage at the existing air handling unit (AHU) and within a pipe chase located within the wall between two bathrooms. Approximately 20 linear feet of asbestos pipe insulation was observed beneath the stage, approximately 25 linear feet was observed at the AHU above the stage and approximately 10 linear feet was observed within the bathroom pipe chase. Asbestos pipe insulation may also be present in other areas of the school including within the crawlspaces that are present beneath the concrete floor slabs. These crawlspaces were not investigated as part of this inspection due to unsafe conditions within the spaces such as confined space conditions and excessive heat. The observed pipe insulation beneath the stage and within the bathroom pipe chase was significantly damaged with debris noted on the floor beneath the pipe insulation under the stage.

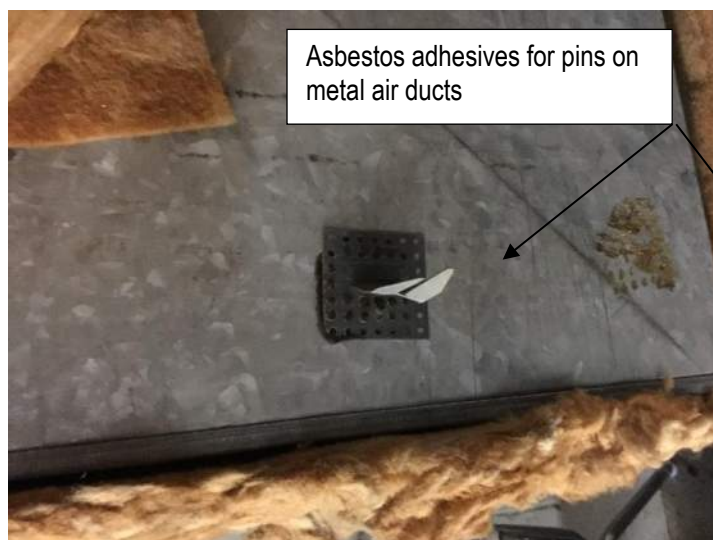
**Stick Pin Adhesive on Air Ducts** – The fibrous-glass thermal insulation on air ducts located above the stage is secured to the metal ducts with stick pins. The adhesive used to glue the pins to the metal ducts contains asbestos. This material is non-friable and appeared to be in good condition. Approximately 600 square feet of this duct is present above the stage.

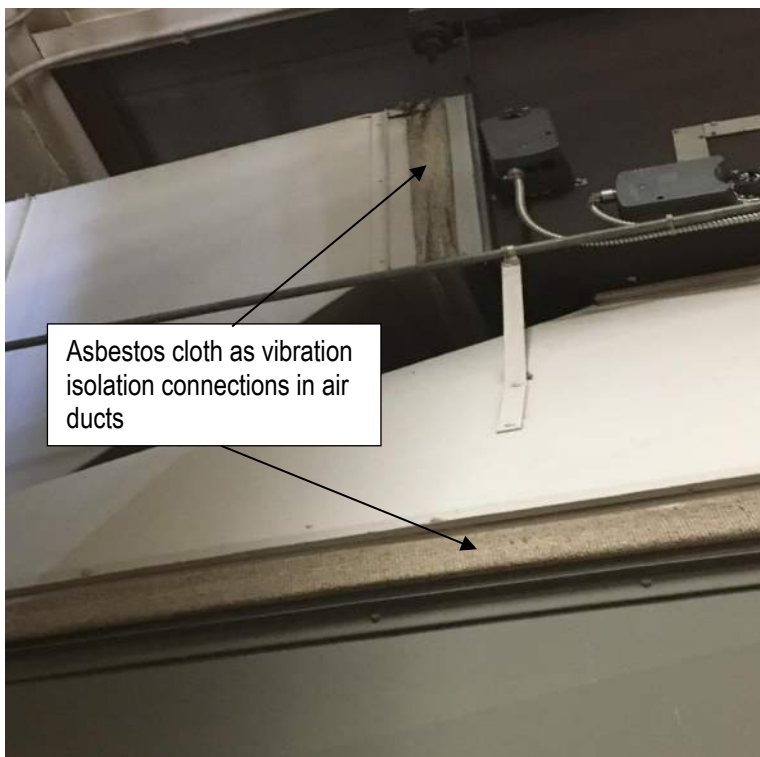
**Vibration Isolation Connectors** – The cloth connections between sections of metal air duct located above the stage in the multi-purpose room have been identified as an ACM. This material is friable and in contact with the pressurized airstream created by the AHU that supplies conditioned air through these ducts. Approximately 50 square feet of this material was observed.

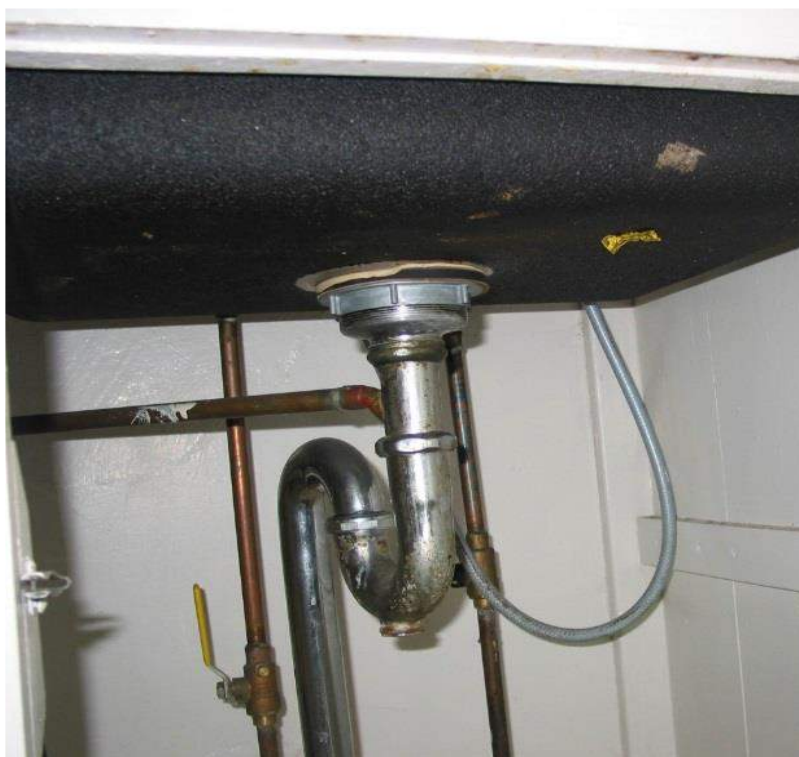
**Coatings Beneath Sinks** – The sinks located in various classrooms and other spaces within the school have a coating applied to the underside of the sink basin. This coating has been identified as an ACM. This material is non-friable and appeared to be in good condition. It is unclear how many (if any) of these sinks will be removed or disturbed as part of the proposed renovation project.

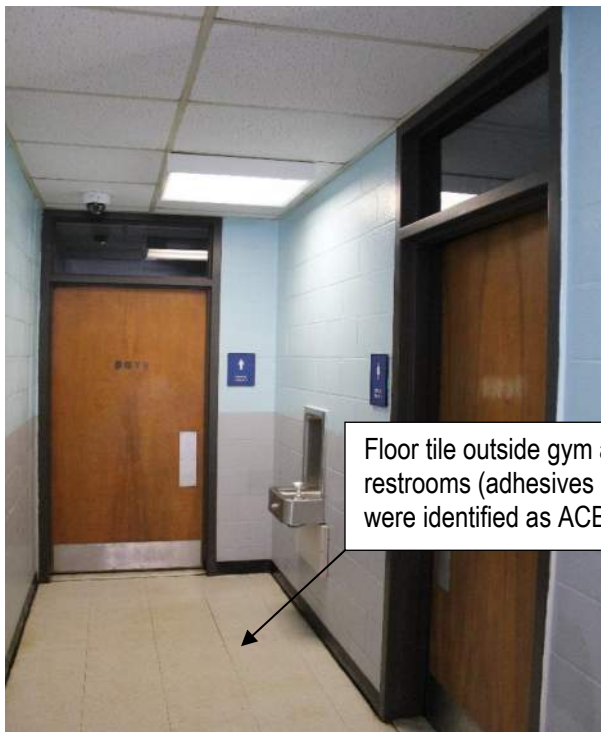
There are various areas of vinyl floor tiles and / or associated adhesives that have been identified as ACBM in various areas within the school. The floor tiles and associated adhesives appeared to be in good condition and are not friable. These tiles / adhesives are in several classrooms as well as in storage spaces. It is not clear if any of these tiles / adhesives will be disturbed by the proposed renovation activities.

Floor tile outside gym area restrooms (adhesives in this area were identified as ACBM)

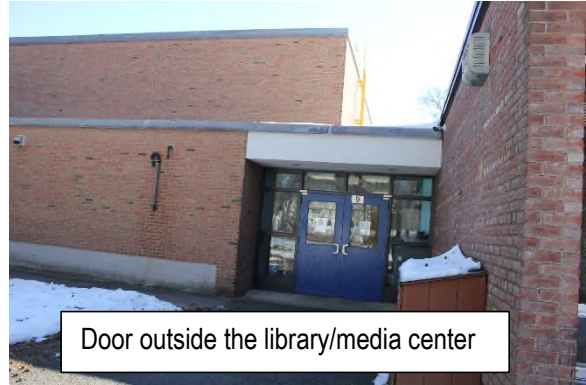
Door outside the library/media center

- Interior Frame Caulking (Type J) – A hard, white caulking was observed on the interior frame to CMU joints on the door outside the library/media center. This same type of caulking was also observed on the frame to CMU joints of certain interior partition doors as described below.

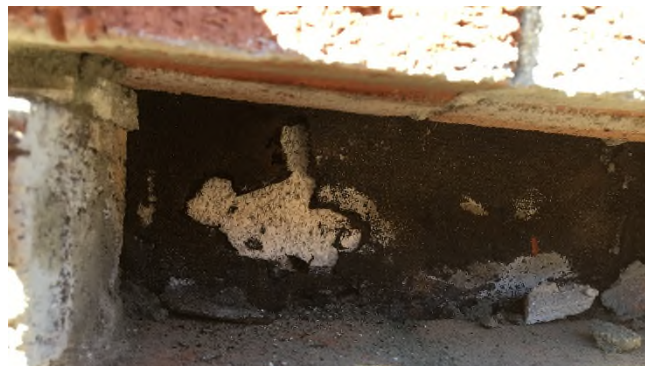
- Waterproofing/Vapor Barriers: Waterproofing vapor barriers were observed during the selective intrusive sampling activities in the wall cavities of the gymnasium, the gymnasium restrooms scheduled to be demolished, and the original 1956 portion of the building next to the restroom windows scheduled to be removed as part of the renovation. The waterproofing material was located on the interior CMU block portion of the wall and separated from the exterior brick façade materials by a void space. Adhesive was observed on the back of the barrier at locations associated with the restroom and the original portion of the building but not on the gymnasium wall areas inspected. These materials were classified as ACBM during the survey.

Black Vapor Barrier on CMU Block Wall  
(Gymnasium South Wall)

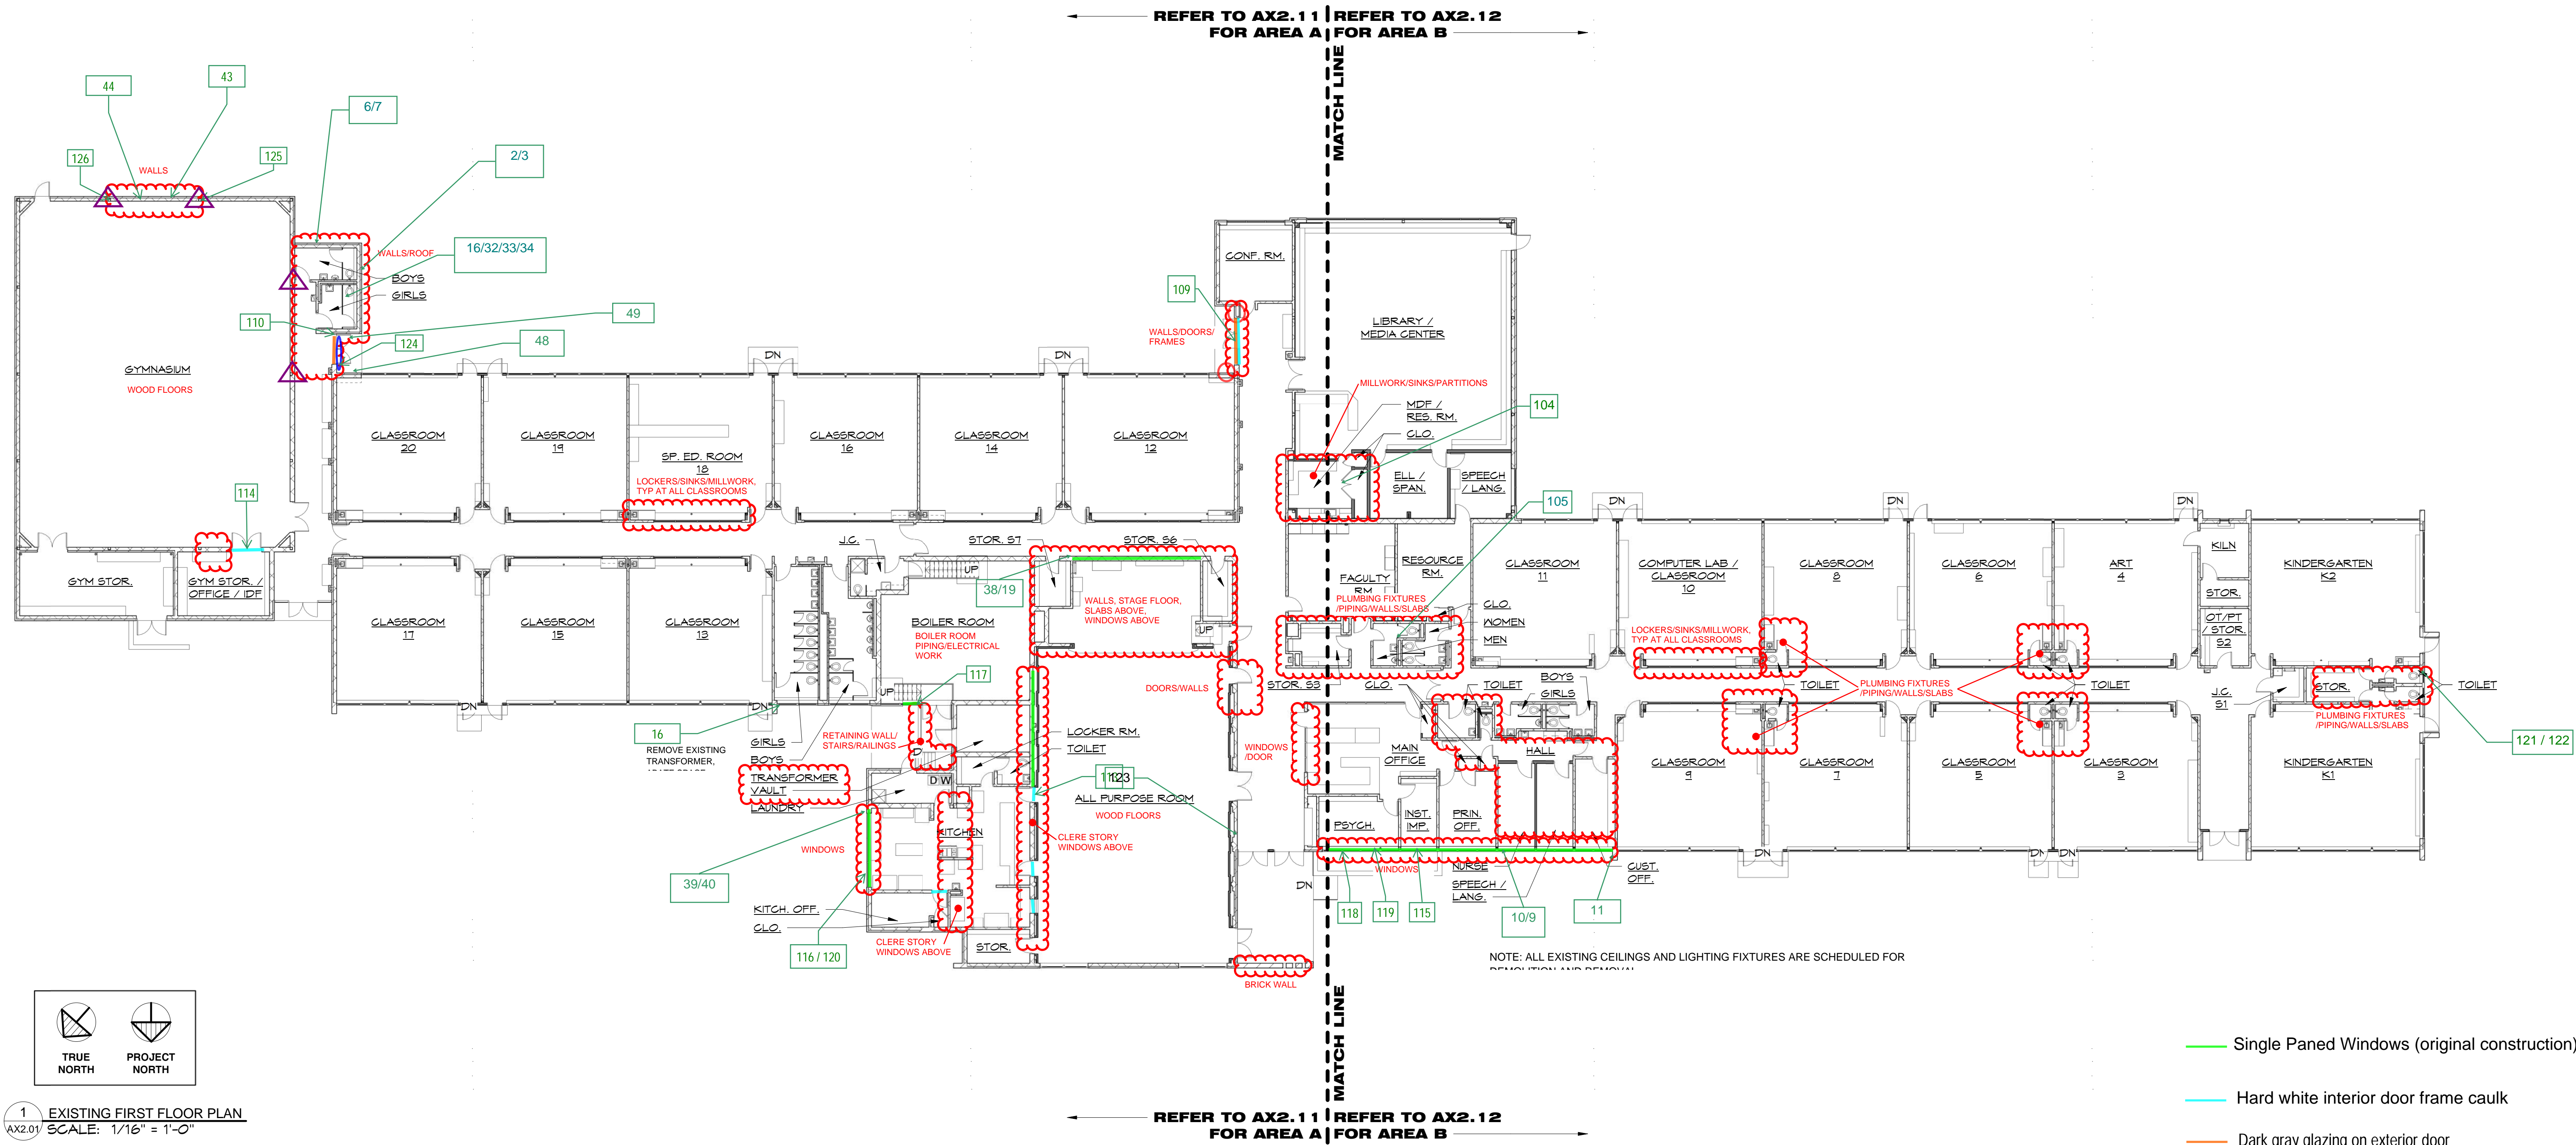
FIGURE 5-1: SUSPECT PCB CONTAINING BUILDING MATERIALS SAMPLE LOCATIONS

- Single Paned Windows (original construction)
- Hard white interior door frame caulk
- Dark gray glazing on exterior door
- Brown exterior door frame caulk
- Light gray over dark gray exterior door frame caulk
- Gray over red expansion joint caulk
- Principle areas of demolition
