SECTION 028319 – LEAD HAZARD REMEDIATION

- A. Work of this Section includes requirements for worker protection, regulated area control measures and waste disposal related to lead in dust cleaning activities involving window well /troughs and paint stabilization of lead-based paint (LBP)-coated door jamb surfaces utilizing 1.0 mg/cm² as the regulatory level (the “Work”) identified during a lead based paint inspection required for a potential childcare program at Stratfield Elementary School located at 1407 Melville Avenue, Fairfield, Connecticut (the “Site”).

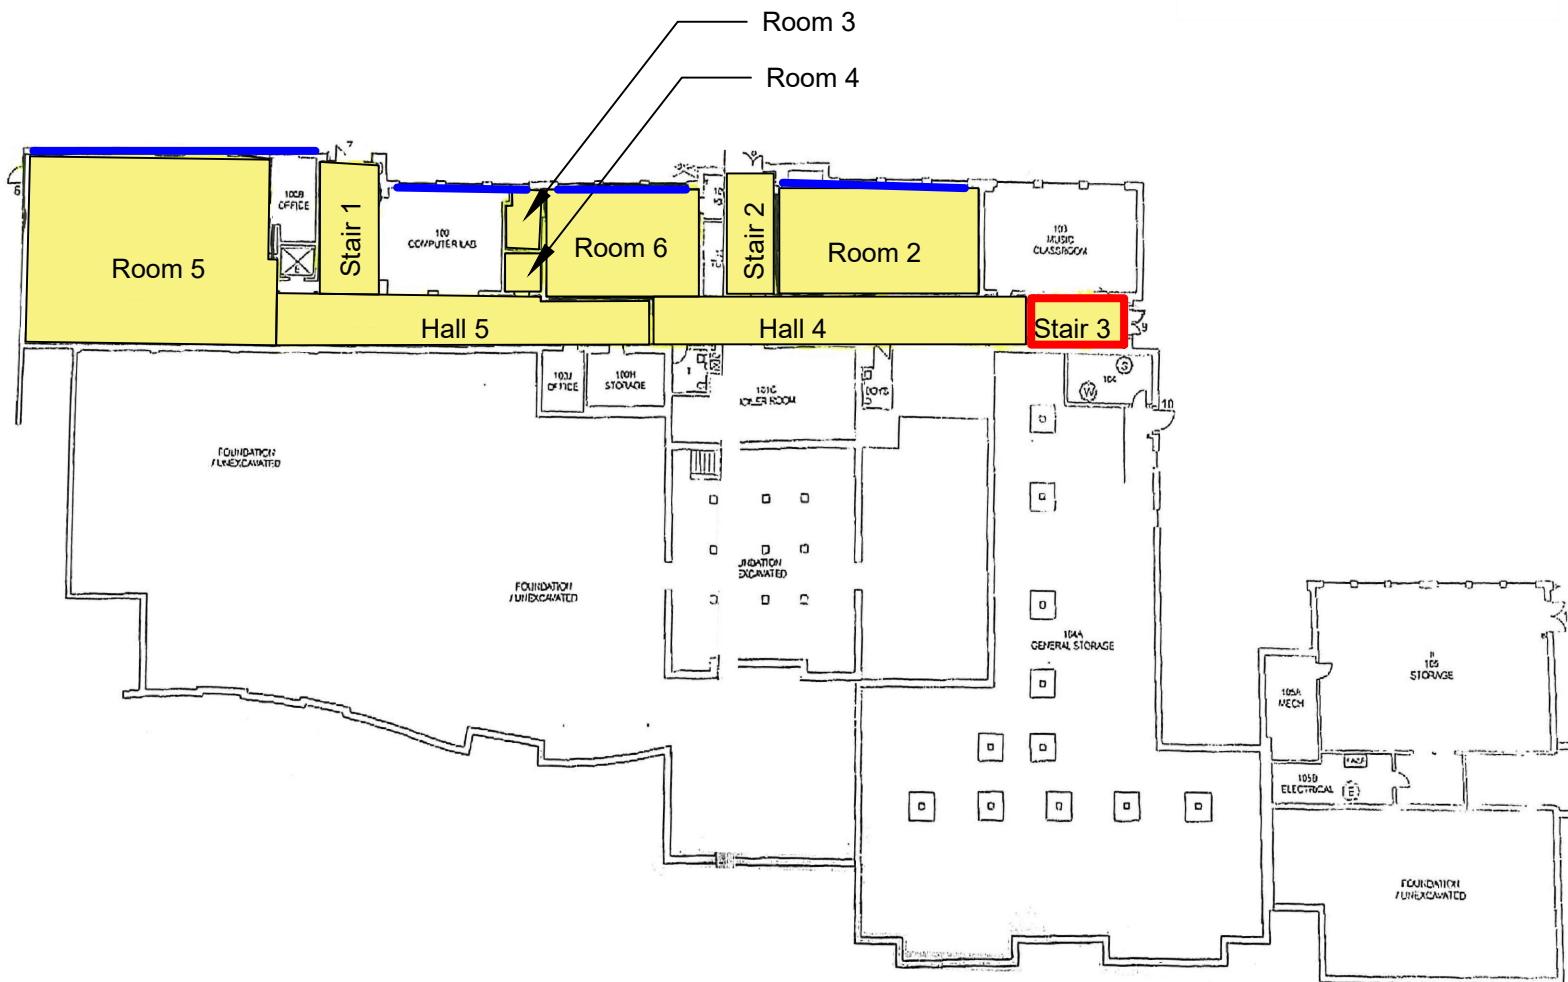
LEGEND:
 Lead Dust Positive
 XRF Lead Positive
 Survey Area

LEAD BASED PAINT - POSITIVE XRF RESULTS

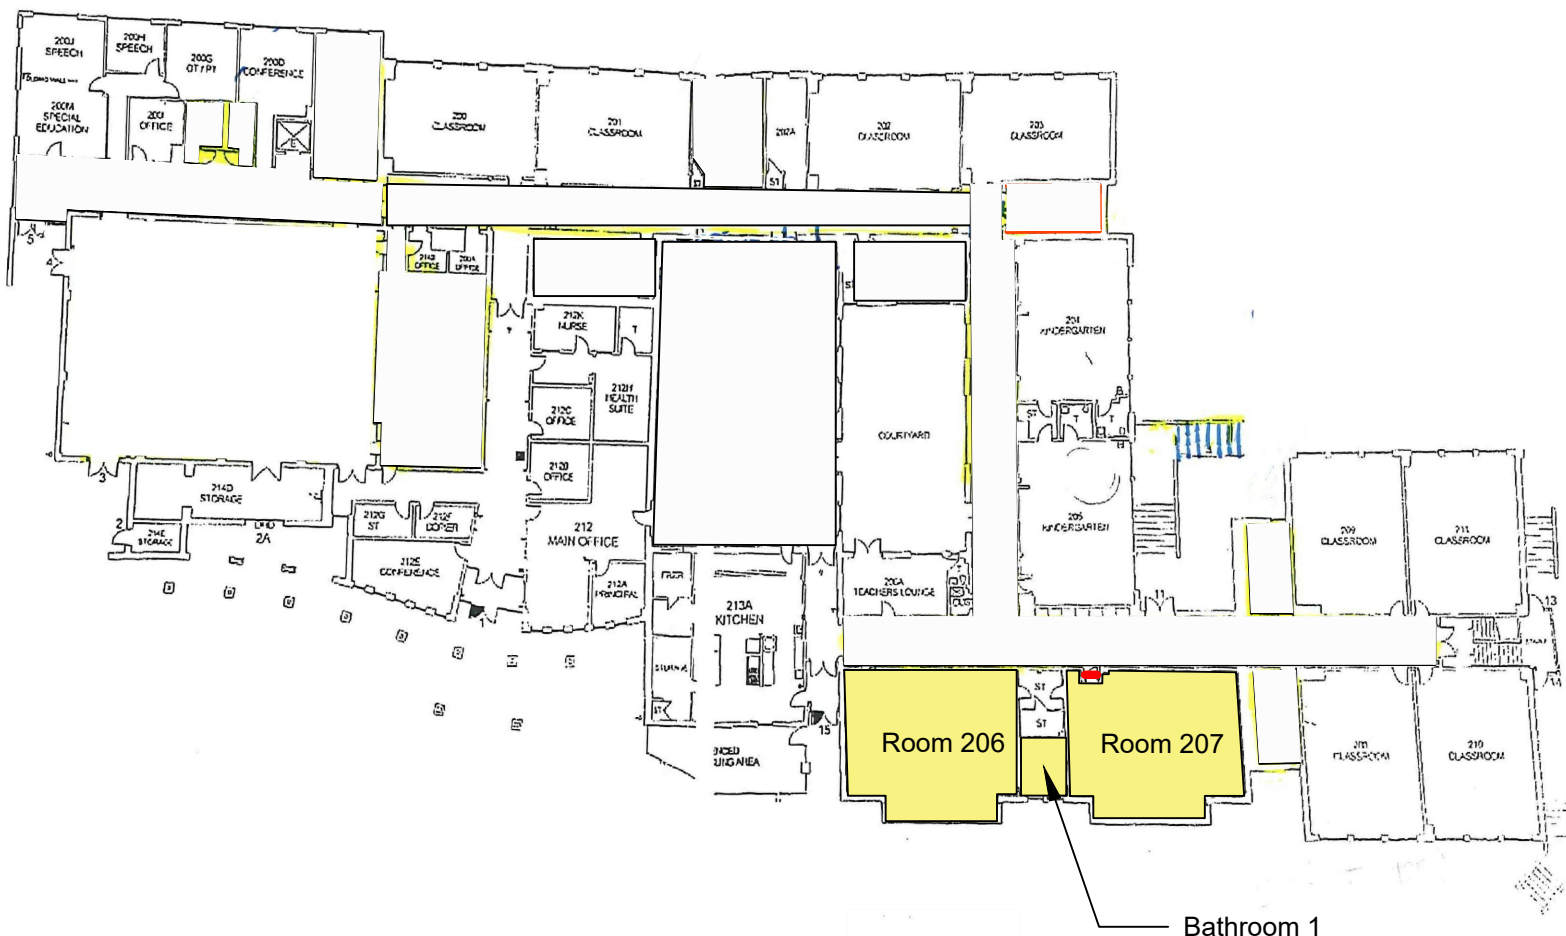
LEAD BASED PAINT - POSITIVE XRF RESULTS

ROOM	COMPONENT	SIDE	SUBSTRATE	CONDITION	COLOR
Room 207	Door Jamb	C	Metal	Deteriorated	Blue

1. **Deteriorated Blue Paint on Metal Door Jamb to Room 207**
- F. **The following components within the proposed childcare area at the Site were identified to be contaminated with lead dust and shall be cleaned using damp rags and a lead cleaning agent in a manner so as to not create liquid waste or an indoor air quality/odor concern:**
