November 26, 2019

Re: Indoor Environmental Assessment
Fairfield Ludlowe High School, Fairfield, Connecticut

ATTACHMENT A: PHOTO LOG

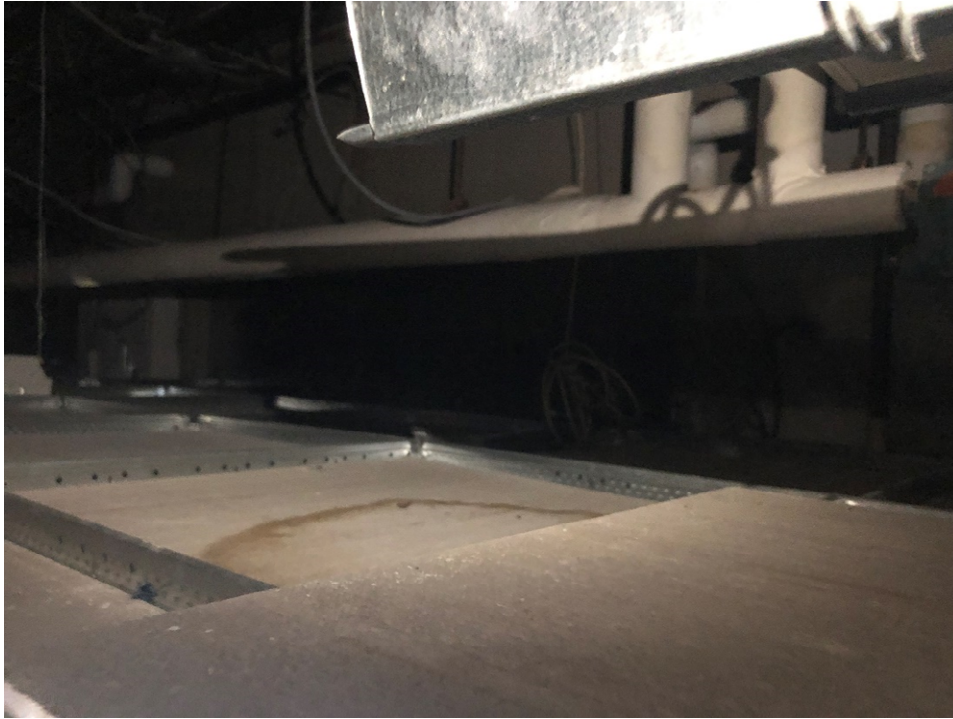
Photo Number: 1

- In the Nursery, Room 126A, 1 water stained ceiling tile was observed. Above the ceiling tile a ceiling mounted air conditioning unit was observed. The stain was likely from leaking water from the unit. Photograph 1 in Attachment A documents this condition.

Description: Stained Ceiling tile in Nursery

- In Nursery, Room 126A, the water stained ceiling tile should be replaced and the air unit should be inspected to assure no leaks or excess condensate can lead to water dripping on ceiling tiles.

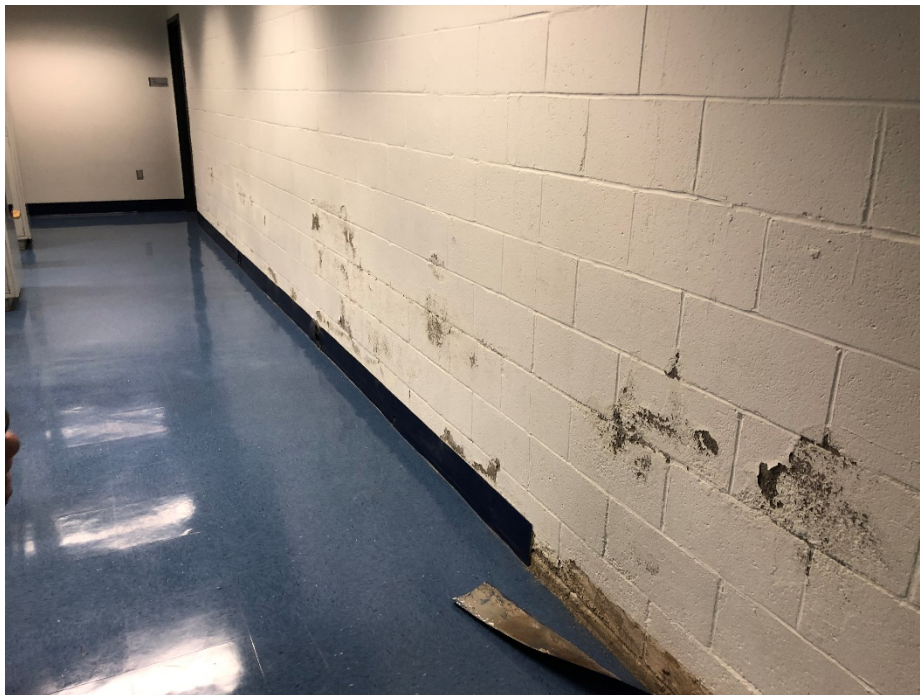
Photo Number: 2

- P.E. Storage, Room 103, is used to store gym equipment. This room did not have general exhaust, which could lead to odors lingering in the room.
- Girls Team Locker Room, Room 018, water staining was observed on the exterior wall in the portion that was below grade. Photograph 2 in Attachment A documents this condition.

Description: Water staining was observed on the exterior wall

- Consider installing a general exhaust in the P.E. Storage Room 103 to help expel the odors from the used equipment stored in the closet area.
- Clean the exterior wall of the Girls Team Locker Room and continue to monitor this area for water damage.

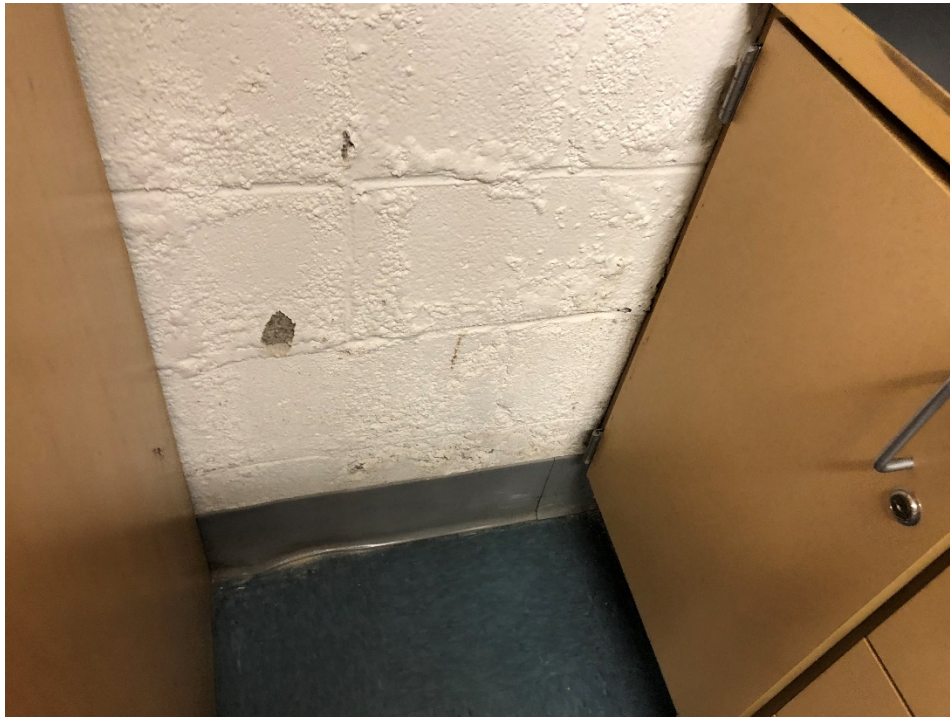
Photo Number: 3

- In the Graphics Laboratory, Room 015, water staining was observed on the rear wall. Photograph 3 in Attachment A documents this condition.
- In the P.E. Office, Room 019, a steam pipe chase travels under the floor. During the assessment the panel to the chase was opened up in several spots. In this room a whistling could be heard which is likely a steam leak in the pipes in the chase. This room also felt more humid than other areas which could lead to a perception of poor air quality.

Description: Water staining was observed on the rear wall

- In the Resource Center, Room 109, the pipe in the ceiling should be repaired to prevent leaks and water stained ceiling tiles should be replaced.
- Clean the exterior wall of the Graphics Lab and continue to monitor this area for water damage.

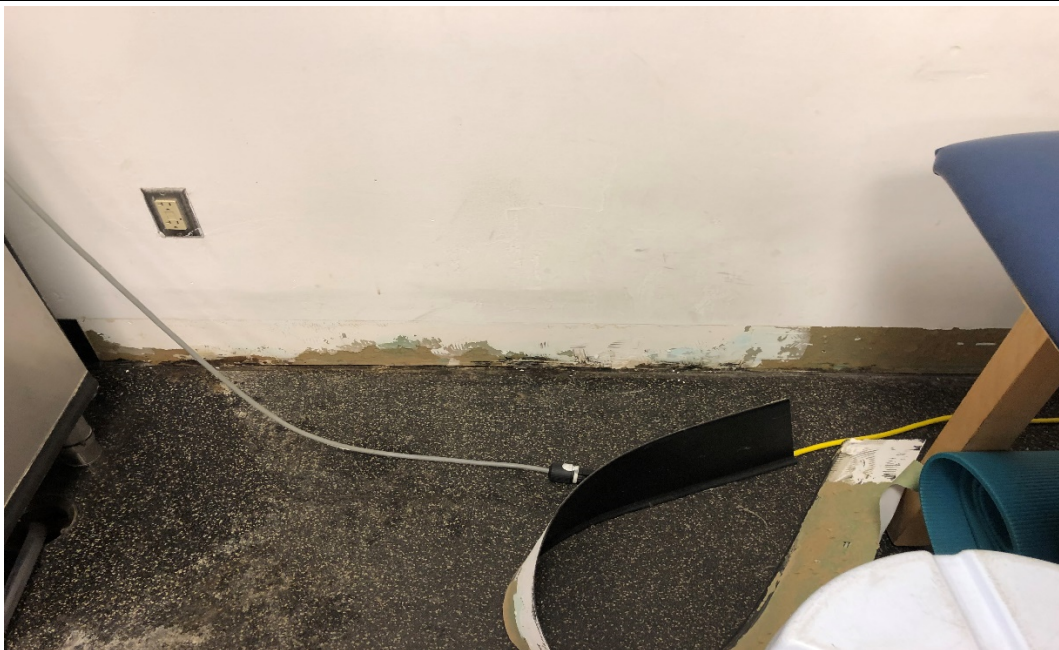
Photo Number: 4

- In the Trainer's Room, Room 027, standing water was observed near the ice machine. Water staining was also observed under the sink on the right-side wall. After pulling back the vinyl cove base on the right side and rear wall, water staining and suspect microbial growth was observed. Photograph 4 in Attachment A documents this condition. Surface sampling for mold content determination was performed. Results indicated mold growth at the base of each wall. The analytical laboratory report is included as Attachment C.

Description: Wall Behind Ice Machine, visible mold growth

Background Debris and/or Description	Miscellaneous Spores Present*	MOLD GROWTH: Molds seen with underlying mycelial and/or sporulating structures†	Other Comments††	General Impression
Lab ID-Version‡: 10923790-1, Analysis Date: 11/14/2019: Tape sample 1A: Gypsum Wall - ICE				
Light	None	4+ <i>Stachybotrys</i> species (spores, hyphae, conidiophores)	None	Mold growth
Lab ID-Version: 10923791-1, Analysis Date: 11/14/2019: Tape sample 2A: Gypsum Wall - Sink				
Light	None	4+ <i>Chaetomium</i> species (ascospores, ascomata, hyphae) 2+ <i>Aspergillus</i> species (spores, hyphae, conidiophores) 1+ <i>Scopulariopsis</i> species (spores, hyphae)	None	Mold growth

- One foot of gypsum board wall should be removed along the rear and right-side walls. Disinfect and clean the area, following removal of building material. The interior of the wall and surrounding area should be inspected prior to reconstruction. Note that the School's Asbestos Hazard Emergency Response Act (AHERA) records should be reviewed prior to disturbing any building materials.

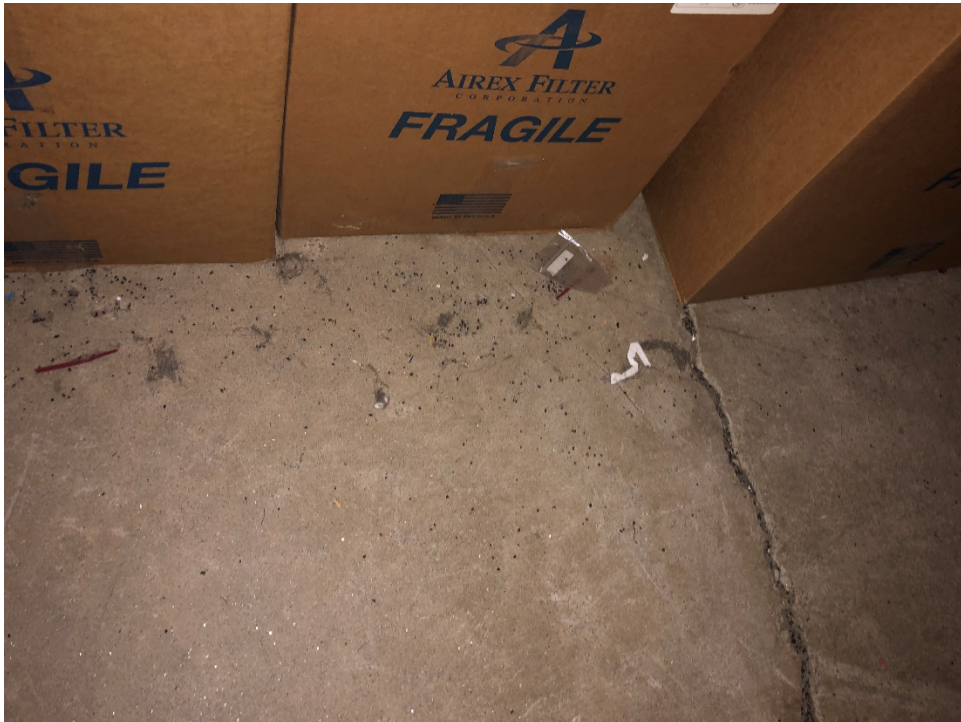
Photo Number: 5

- In the Mechanical Tunnel, Room 031B, suspect rodent droppings were observed on the floor. Photograph 5 in Attachment A documents this condition.
- The Fuel Oil Pump Room in the closet in Room 030 Art CAD/Studio had a strong odor of fuel oil.

Description: Suspect Rodent droppings

- The steam leak in the chase near the P.E. Office, Room 019 should be repaired.
- The suspect rodent droppings should be cleaned from the Mechanical Tunnel, Room 031B. Review the schools rodent control procedures.

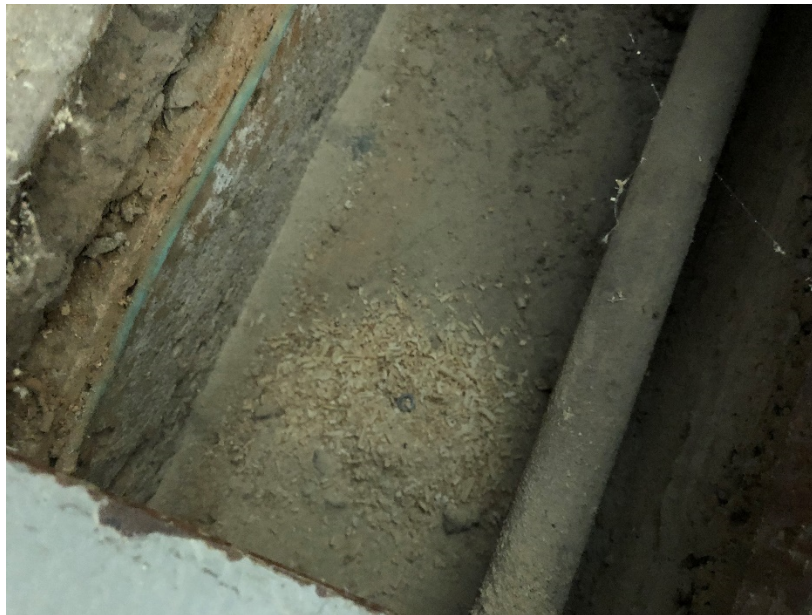
Photo Number: 6

- In the Wood Shop, Room 024, in the steam pipe chase, saw dust was observed. Photograph 6 in Attachment A documents this condition.
- In the Transportation Technology Room, Room 010, a wet bucket of saw dust and a bucket of water near the parts washer were observed. Photograph 7 in Attachment A documents this condition.

Description: Saw dust in Steam chase

- Evaluate and implement methods to improve exhausting air from the Fuel Oil Pump Room to reduce the fuel odor in that area.
- Clean out the steam chase of all organic matter in The Wood Shop, Room 024.

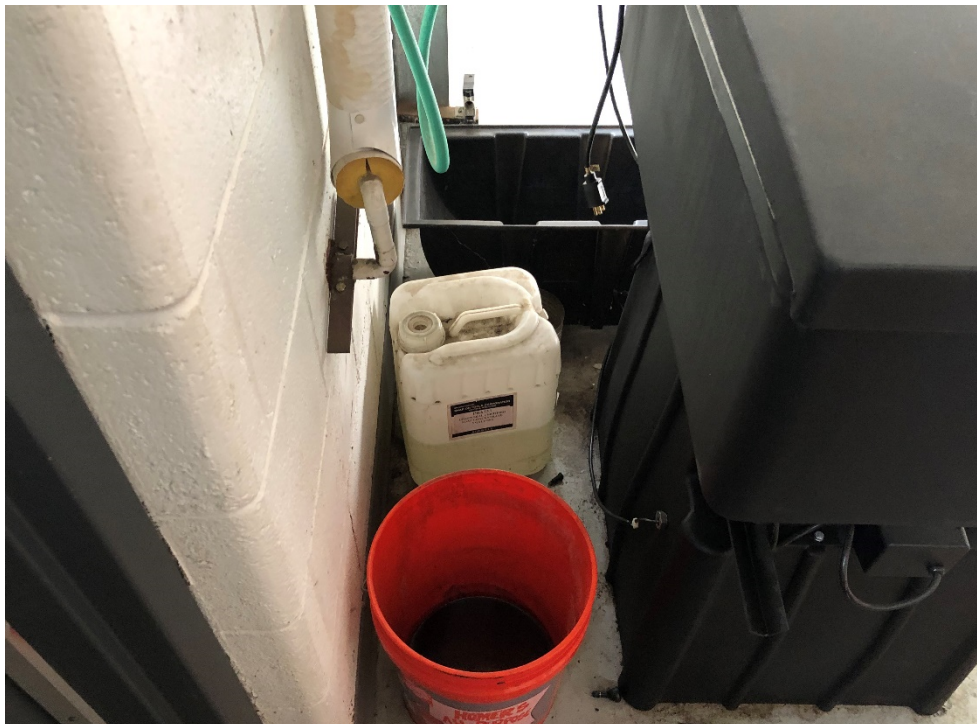
Photo Number: 7

Description: Container of water near parts cleaner

- Dispose of wet organic matter and standing water in the Transportation Technology Room 010.
- Clean out old supplies from beneath the sinks in the Art Rooms.
- Continue to monitor school areas for water damage and excess moisture in building materials. Continue maintenance program of replacing ceiling tiles if any water damage is observed.
