SUBJECT SITE:	Stratfield Elementary School 1407 Melville Avenue Fairfield, CT 06825
CLIENT:	Fairfield Public Schools Maintenance Department 418 Meadow Street Fairfield, CT 06824
INSPECTION DATE:	November 28, 2018
BIG EAST PROJECT #:	18662

LTD. LEAD BASED PAINT INSPECTION

LEAD SURVEY - 1st Floor

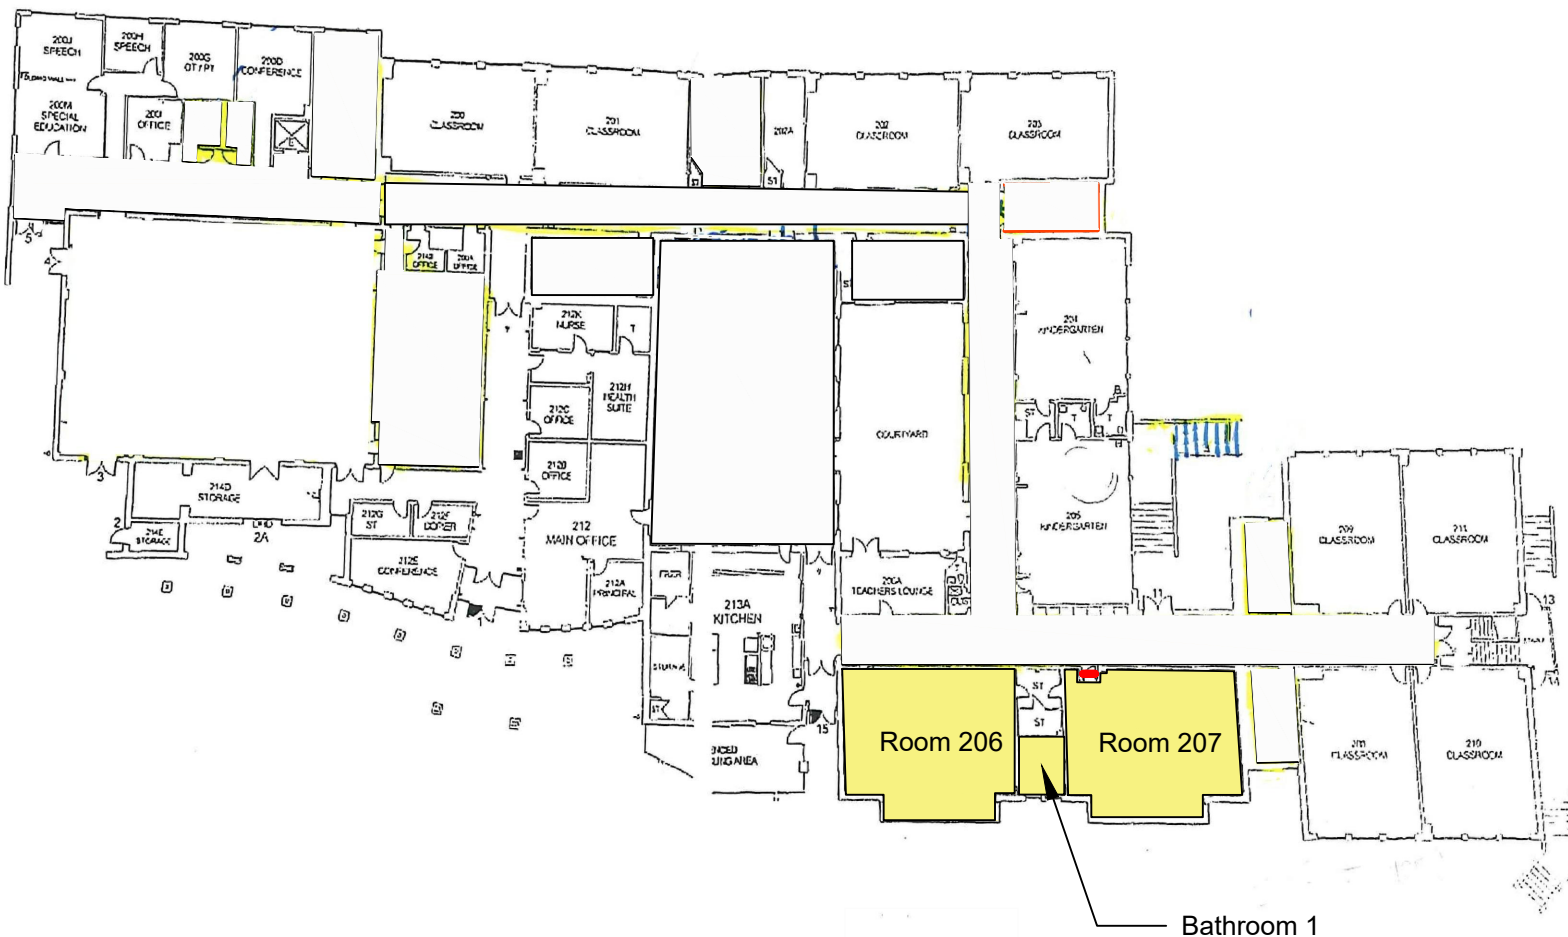
ROOM	COMPONENT	SIDE	SUBSTRATE	CONDITION	COLOR
Room 207	Door Jamb	C	Metal	Deteriorated	Blue

No Dust wipe results were elevated
