August 15, 2017

Re: **Hazardous Building Materials Survey Report Amendment**
Holland Hill Elementary School, Fairfield, Connecticut

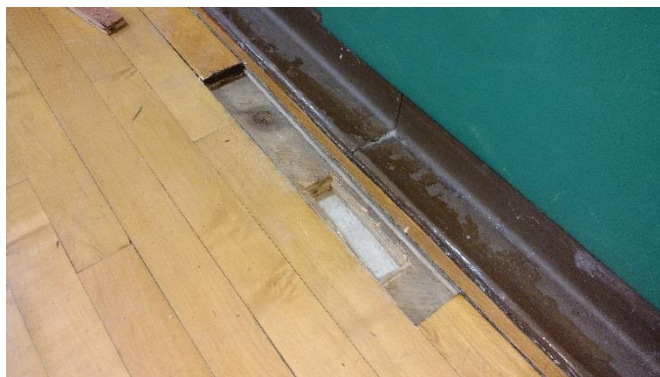
Materials below the wood flooring were inspected at three locations spatially distributed around the gymnasium. Materials observed included multiple layers of plywood sheeting and spacer materials between the lower layer of plywood and the underlying concrete slab (see photo to the right).

Two samples of the spacer materials were submitted for asbestos analysis and determined to be non-asbestos containing materials. The complete analytical laboratory report is provided in Attachment A.

No other suspect ACM were observed beneath the wood flooring during the survey.

Typical Wood Flooring and Underlying Materials

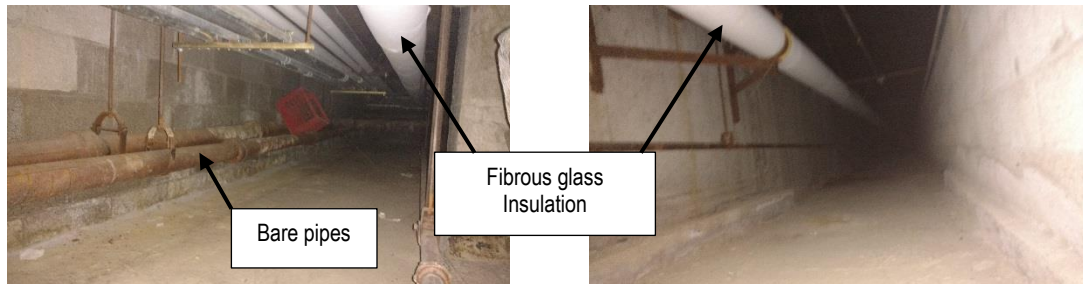
Access to the utility tunnels was available at two locations, within the boiler room and from the access panel at the east end of the school (near the gymnasium). At both locations, visual observations indicated that the pipes were either bare (no insulation) or were covered with fibrous glass insulation. Due to confined space safety concerns, the inspection did not include the entire tunnels but was limited to areas that could be observed from the two access points using flashlights (see photos below).

The observations appear to confirm the information within the AHERA reports and other historic documents which state that ACM from within the tunnels was previously abated.
