October 15, 2018

Re: Environmental Assessment, Timothy Dwight Elementary School
1600 Redding Road, Fairfield, Connecticut

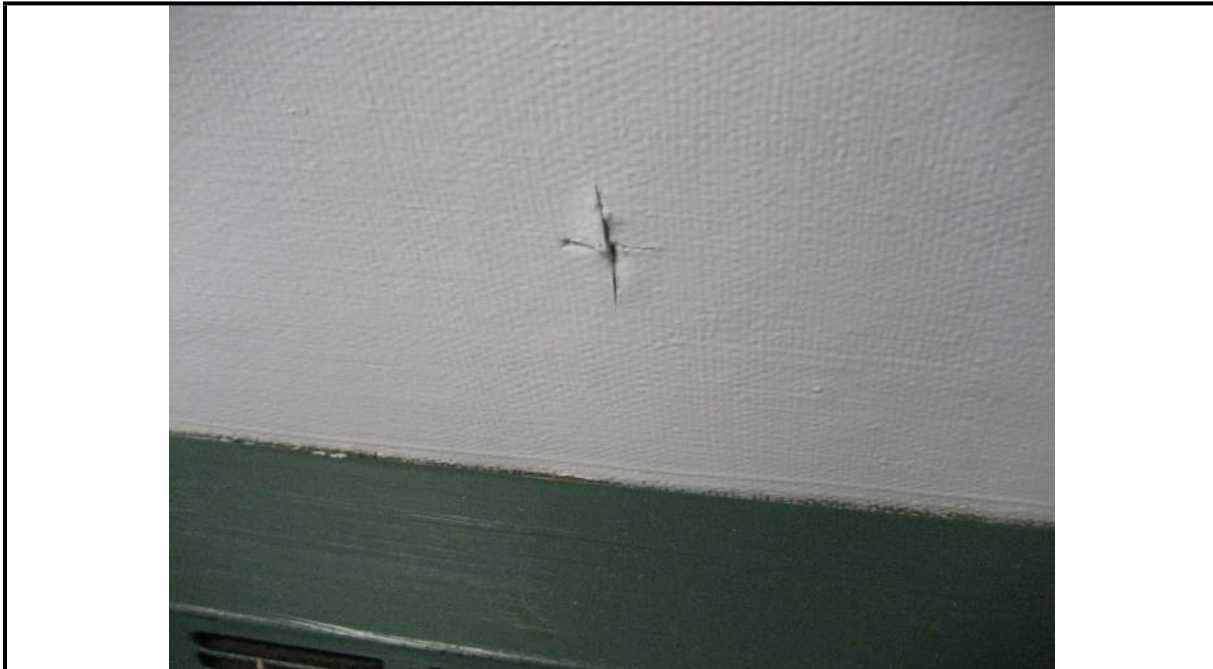
Photo Number: 1

Description: Wallboard material in Classroom 10, prior to borescope inspection

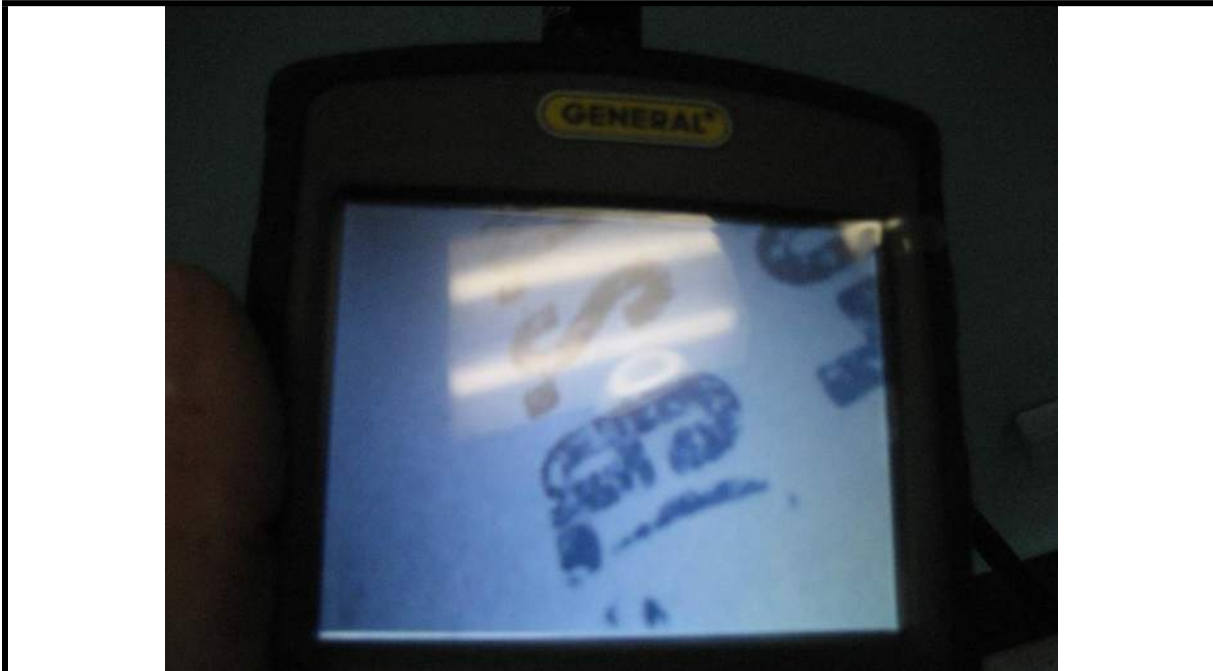
Photo Number: 2

- A borescope was used to inspect the interior wall cavities of the layered cellulose-based wall in classrooms 10, 15 and 17. This inspection included two walls in classroom 10, and one wall in classroom 15 and 17. No water damage or suspect fungal growth was observed in the wall cavities inspected with the borescope.

Description: Wall cavity in Classroom 10

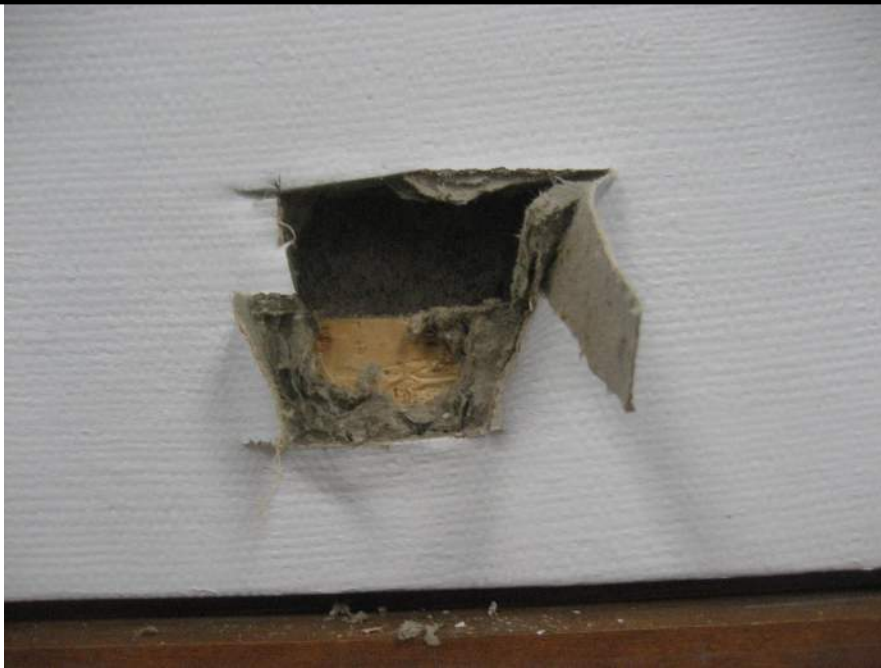
Photo Number: 3

- Small portions of the bulletin boards in classrooms 10, 15, and 17 were removed during the assessment to observe the conditions behind the bulletin boards. No suspect fungal growth was observed.

Description: Interior and surface of bulletin board in Classroom 10

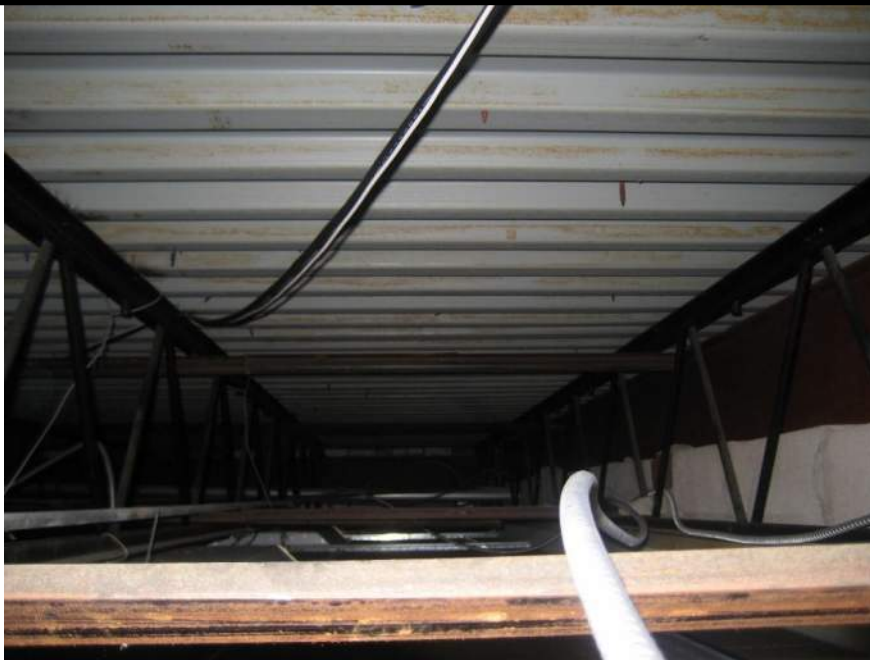
Photo Number: 4

- No evidence of active water leaks, water staining, or fungal growth was observed on the acoustical ceiling tiles in classrooms 10, 15, and 17.
- Limited evidence of oxidation was observed on the corrugated metal decking above the acoustical ceiling tiles in rooms 10, 15, and 17. This may be related to elevated moisture in the building or storage of building materials during construction. The roof was reportedly replaced three years ago and appears to be in good condition.

Description: Above suspended ceiling in Classroom 10

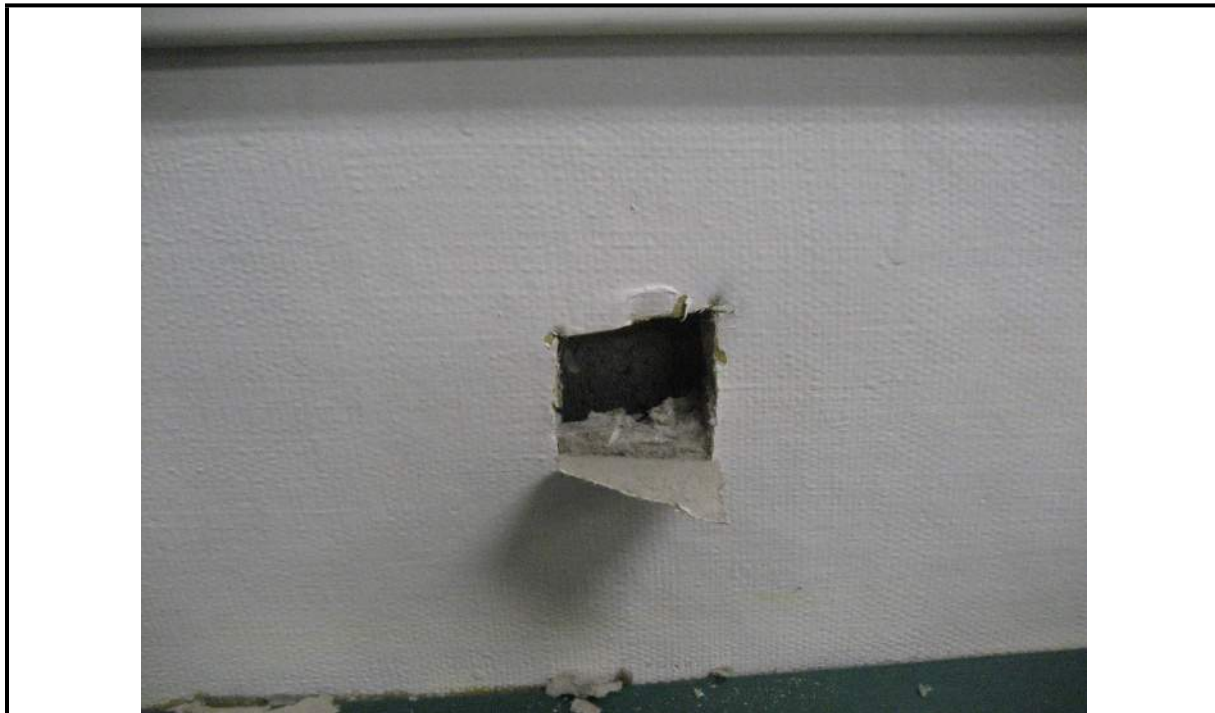
Photo Number: 5

Description: Wallboard material in Classroom 15, prior to borescope inspection

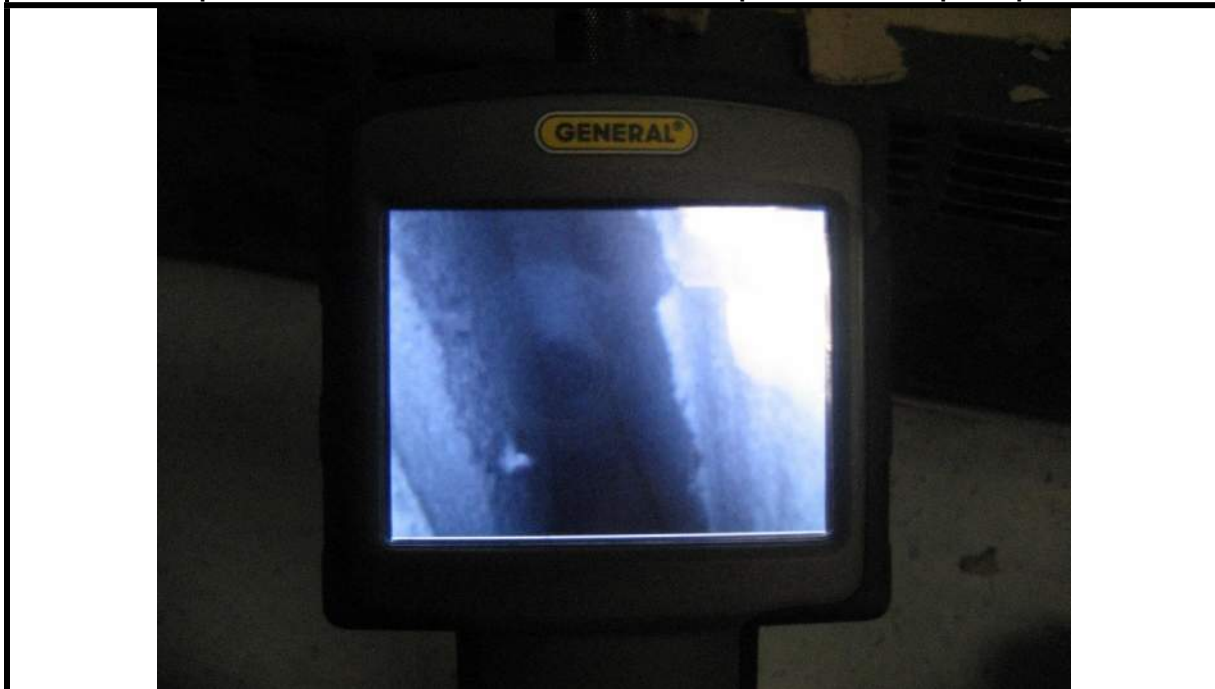
Photo Number: 6

Description: Wall cavity in Classroom 15

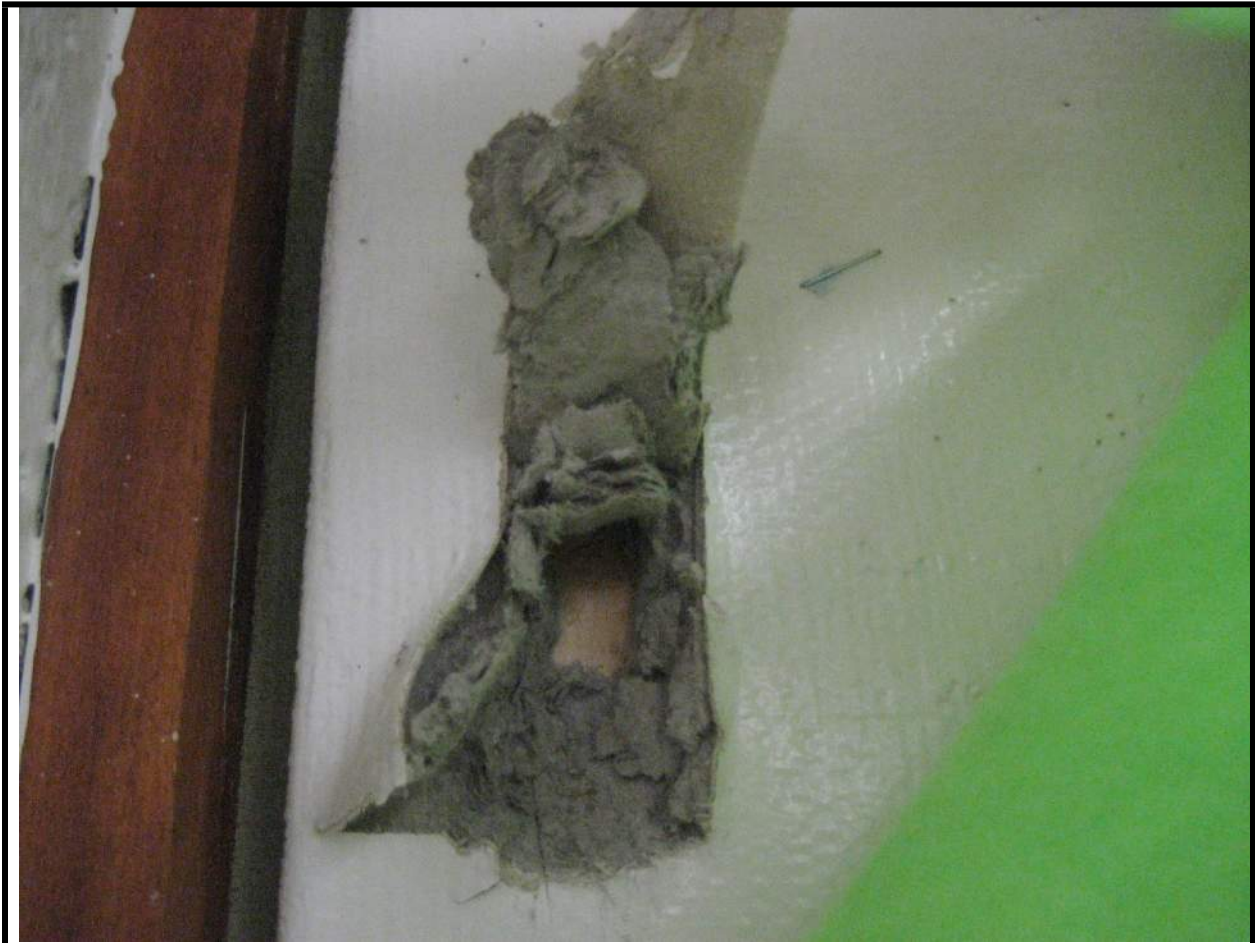
Photo Number: 7

Description: Interior and surface of bulletin board in Classroom 15

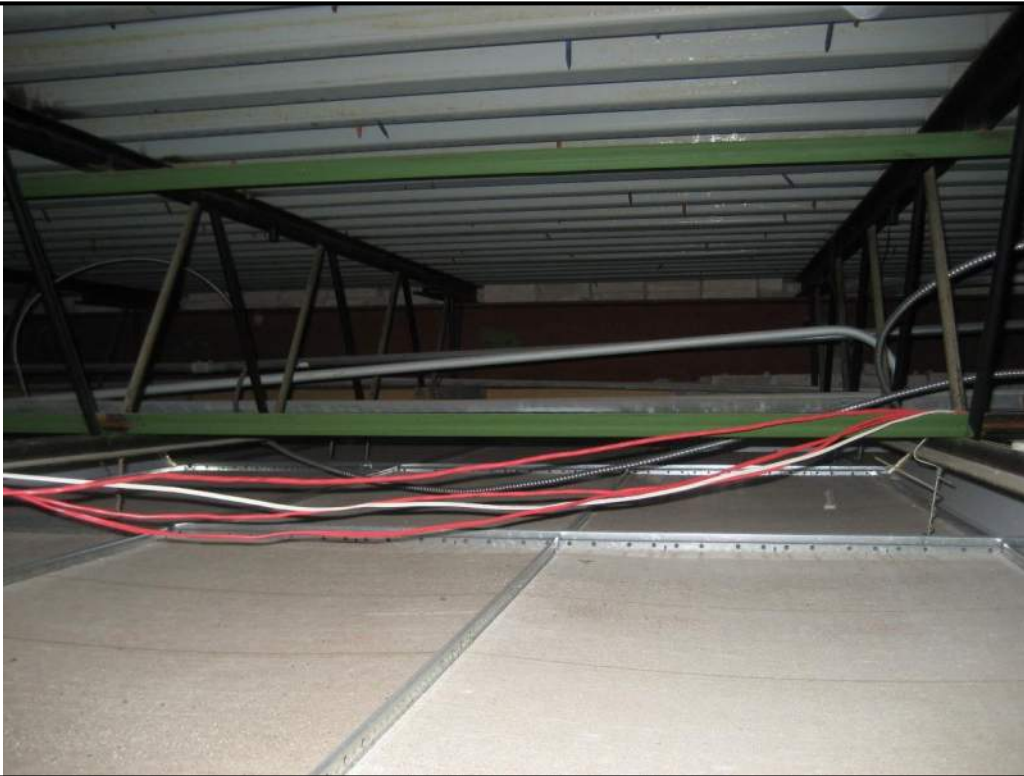
Photo Number: 8

Description: Above suspended ceiling in Classroom 15

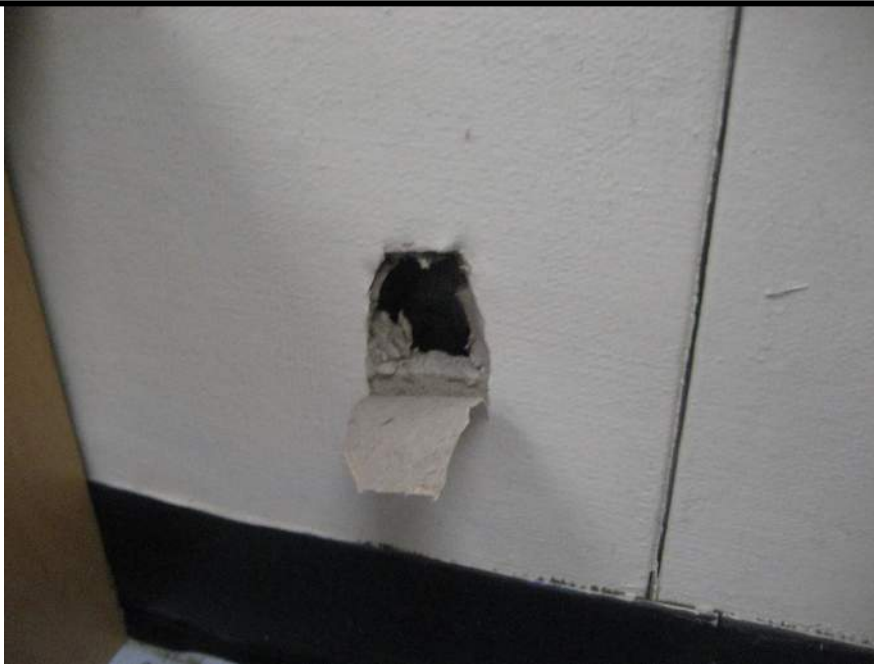
Photo Number: 9

Description: Wallboard material in Classroom 17, prior to borescope inspection

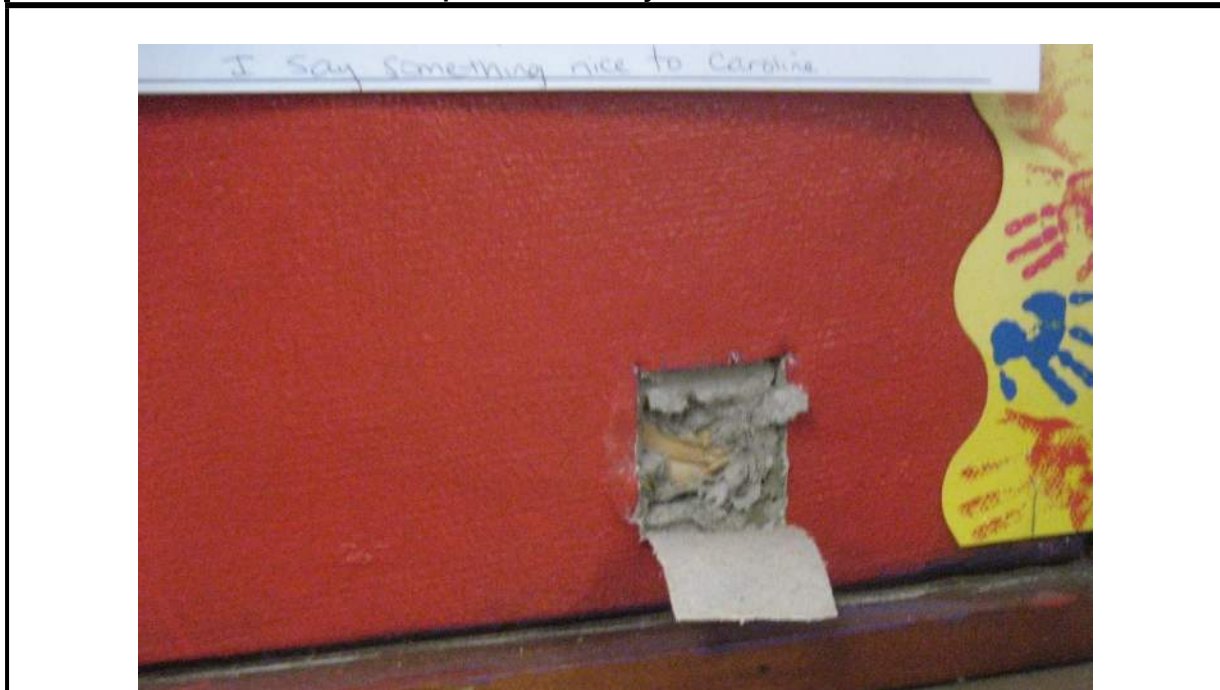
Photo Number: 11

Description: Interior and surface of bulletin board in Classroom 15

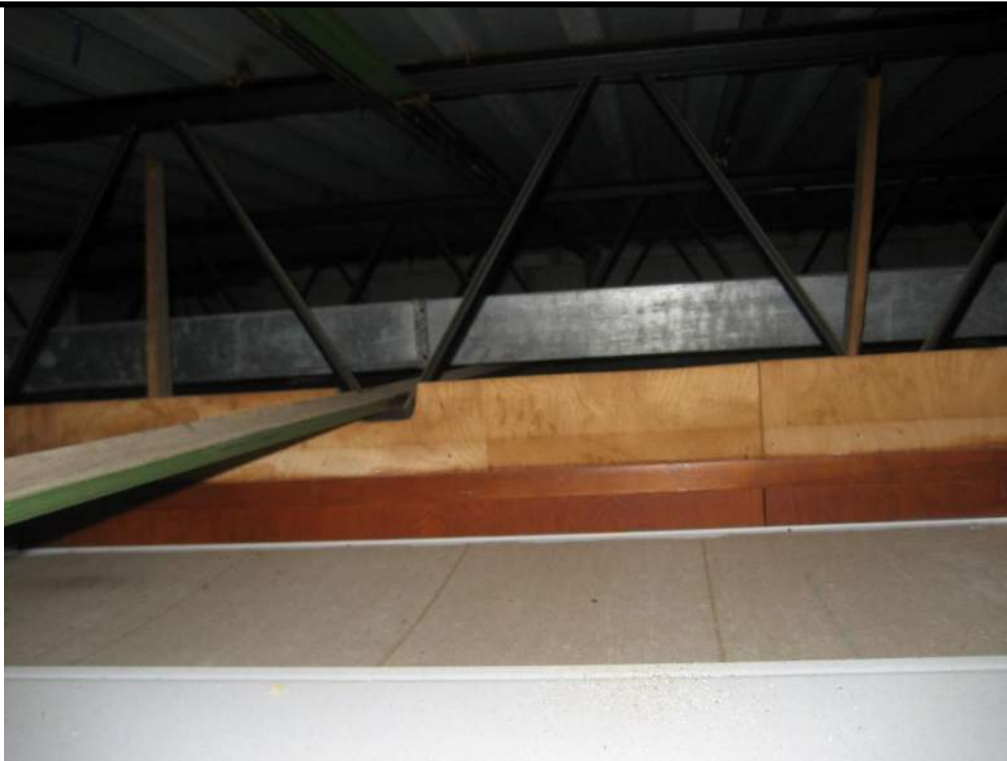
Photo Number: 12

Description: Above suspended ceiling, Classroom 17

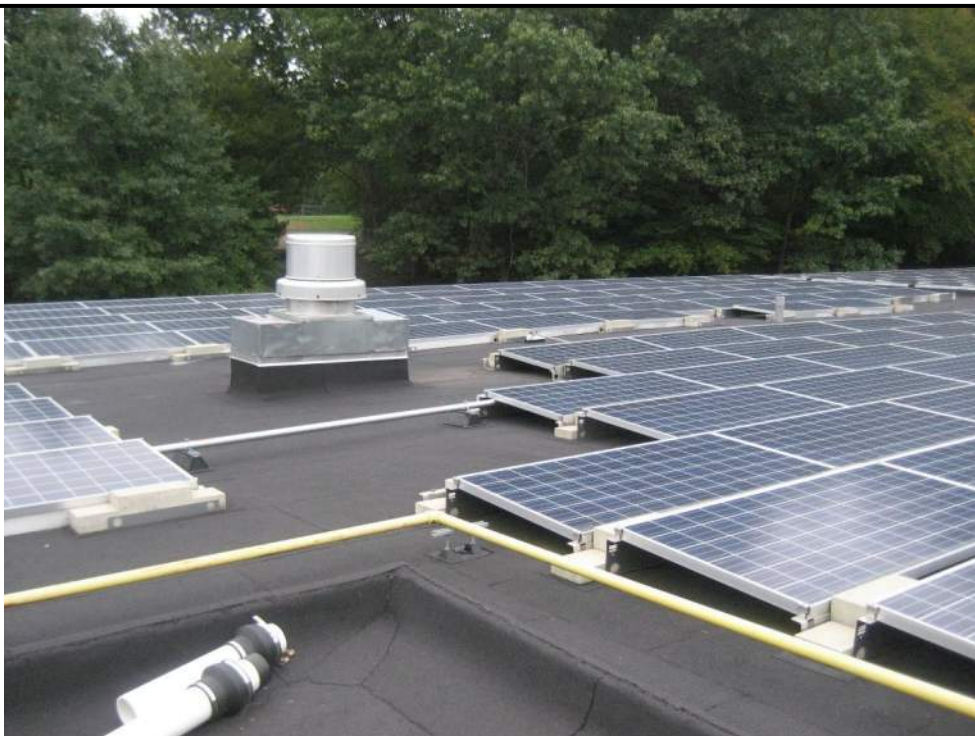
Photo Number: 13

Description: School rooftop

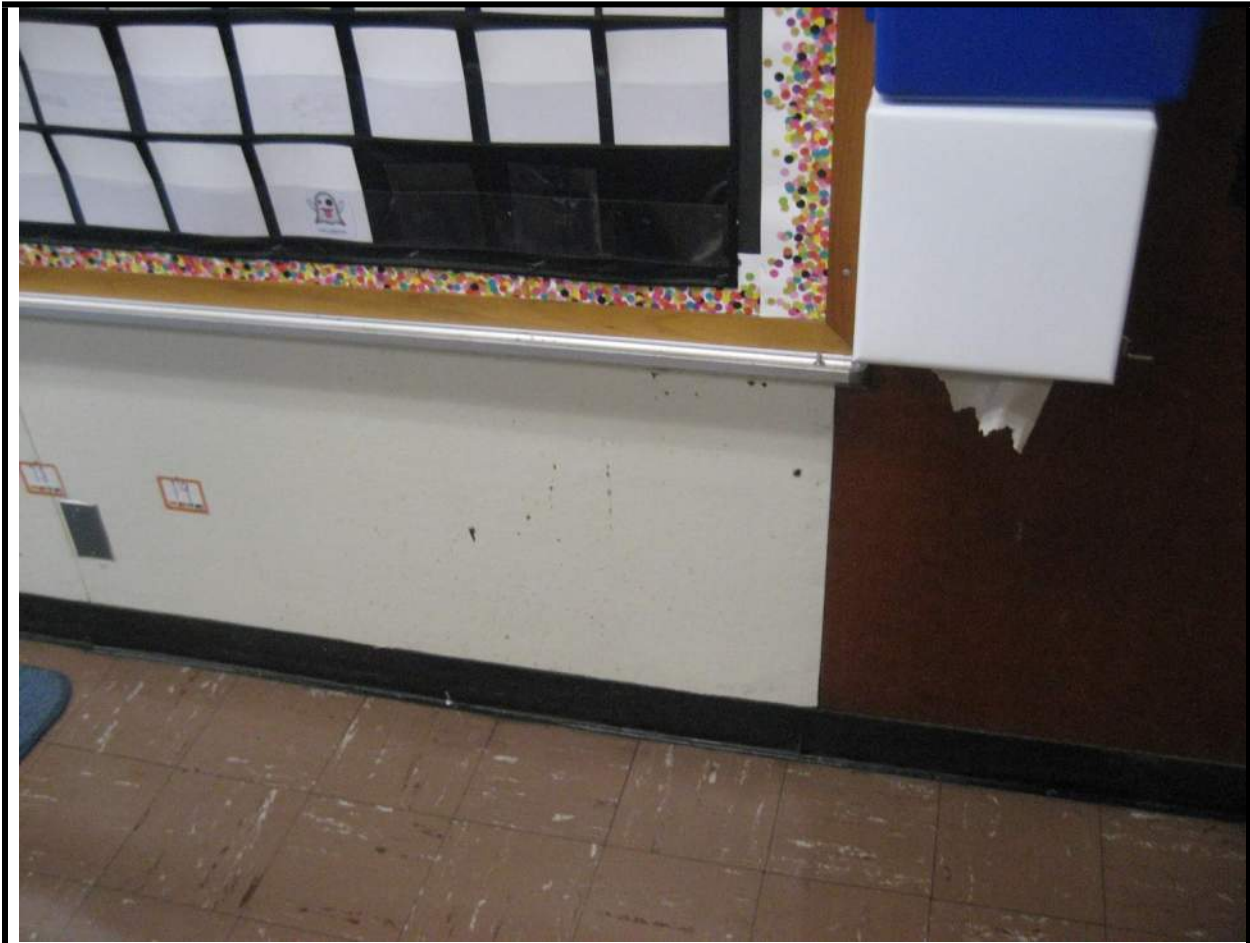
Photo Number: 14

- A solar array is located on the majority of the roof of the school, including above classrooms 10, 15, and 17.
- In classroom 8, a small quantity of suspect fungal growth was observed on the wallboard near a sink. This area, reportedly, is where students routinely wash and dry their hands and where the trash barrel is stored. Adjacent to this area, clipboards were hung/stored on the wall. There was some light particulate debris behind these clip boards.

Woodard & Curran conducted a moisture survey in areas noted above on October 4, 2018. The moisture survey included those rooms specified above including ceiling and wallboard materials. The moisture survey indicated that the moisture content was less than 15%, indicating dry conditions, in classrooms 10, 15, and 17 as well as the area of suspect fungal growth in classroom 8.

Description: Classroom 8, Wall with suspect microbial growth on surface

- Clean the wall surfaces in classroom 8. Specifically, clean the wall surfaces to the left of the sink and the lower portion of the wall where the clipboards are hanging. Use a disinfectant or cleaning product that is approved by the School Department for housekeeping activities. Do not over saturate the area, but thoroughly wipe the wall surfaces and allow to adequately dry.
