Toni R. Jones Ed. D.
Superintendent of Schools

October 23, 2018

Re: Environmental Assessment, Timothy Dwight Elementary School
1600 Redding Road, Fairfield, Connecticut

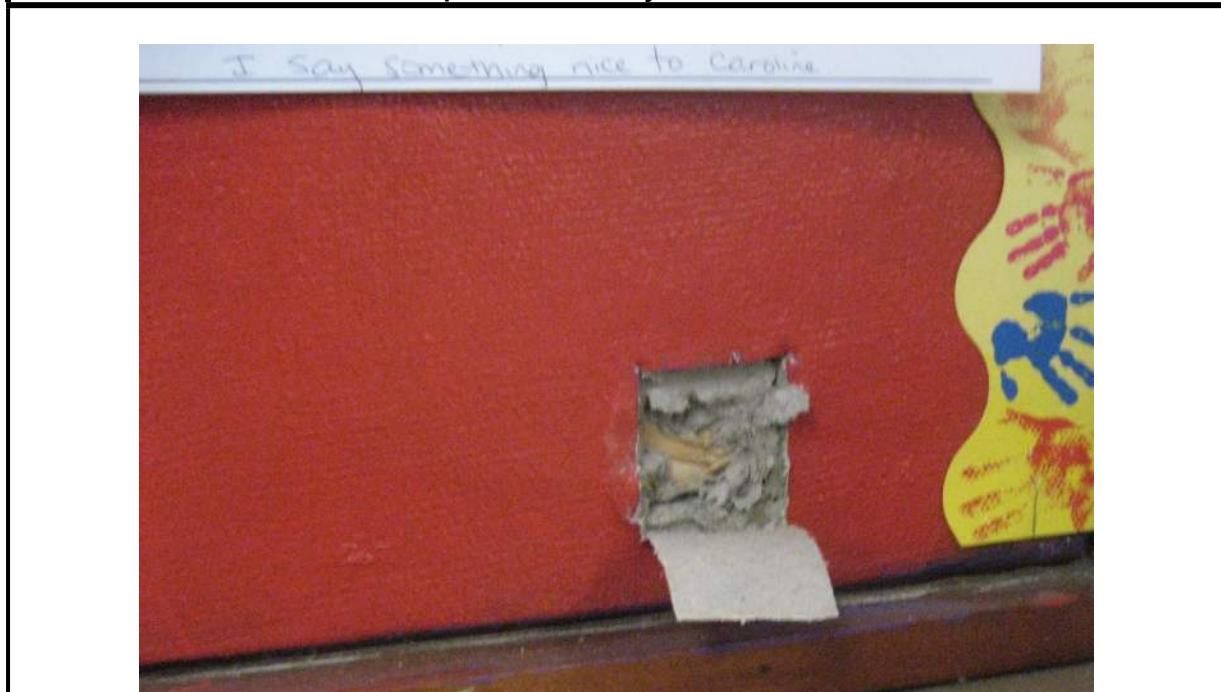
Photo Number: 11

Description: Interior and surface of bulletin board in Classroom 15
