# Hazardous Materials Survey Report

Holland Hill  
Elementary School

105 Meadowcroft Road  
Fairfield, Connecticut

230299  
**Kenneth Boroson**  
**Architects**  
March 2017

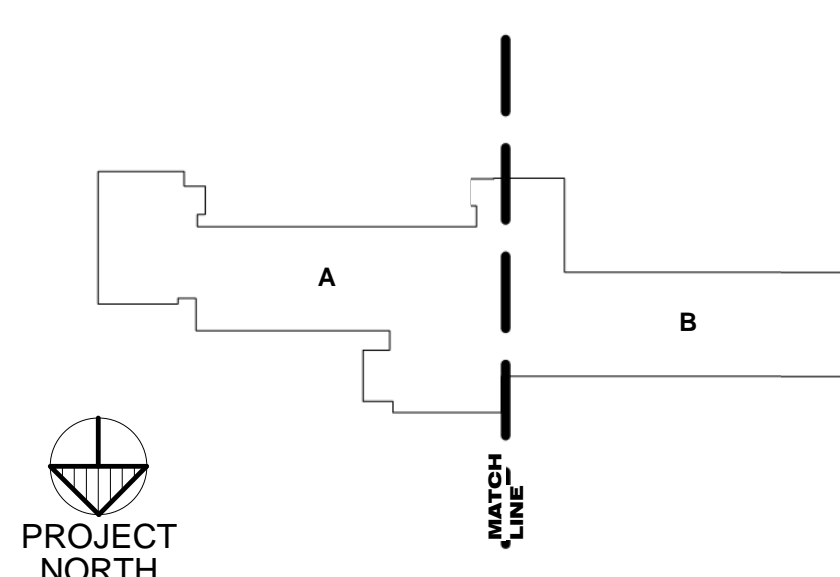
FIGURE 5-1: SUSPECT PCB CONTAINING BUILDING MATERIALS SAMPLE LOCATIONS

A summary of the suspect materials observed and the samples collected is provided in Table 5-1 and the locations of the samples collected are depicted on Figure 5-1.

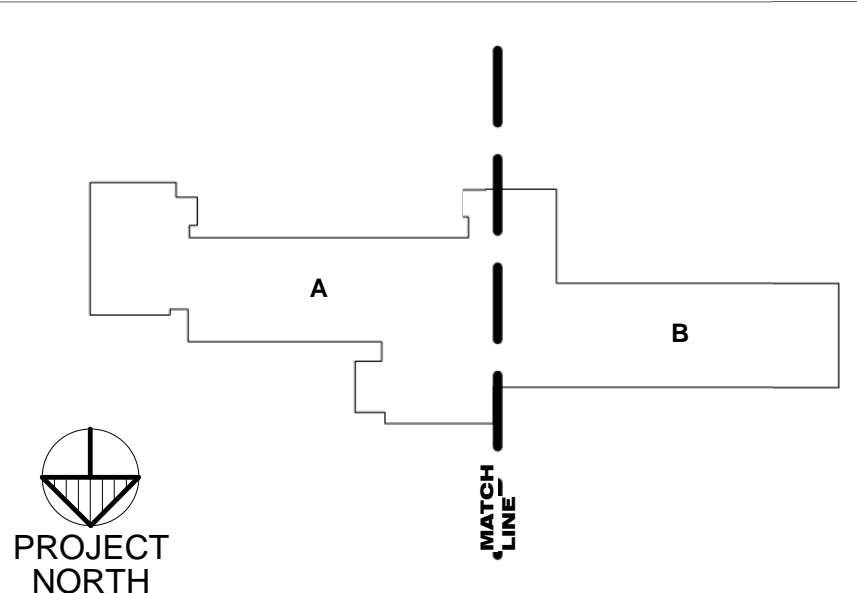
- Single Paned Windows (original construction)
- Hard white interior door frame caulk
- Dark gray glazing on exterior door
- Brown exterior door frame caulk
- Light gray over dark gray exterior door frame caulk
- Gray over red expansion joint caulk
- Principle areas of demolition
