Limited Indoor Air Quality Assessment and Sampling Report

November 1, 2022 Fairfield Roger Ludlowe High School 785 Unquowa Road, Fairfield CT

RE: Limited Indoor Air Quality Assessment and Sampling Fairfield Roger Ludlowe High School 785 Unquowa Road, Fairfield, CT Fuss & O'Neill Project No. 20211081.A20

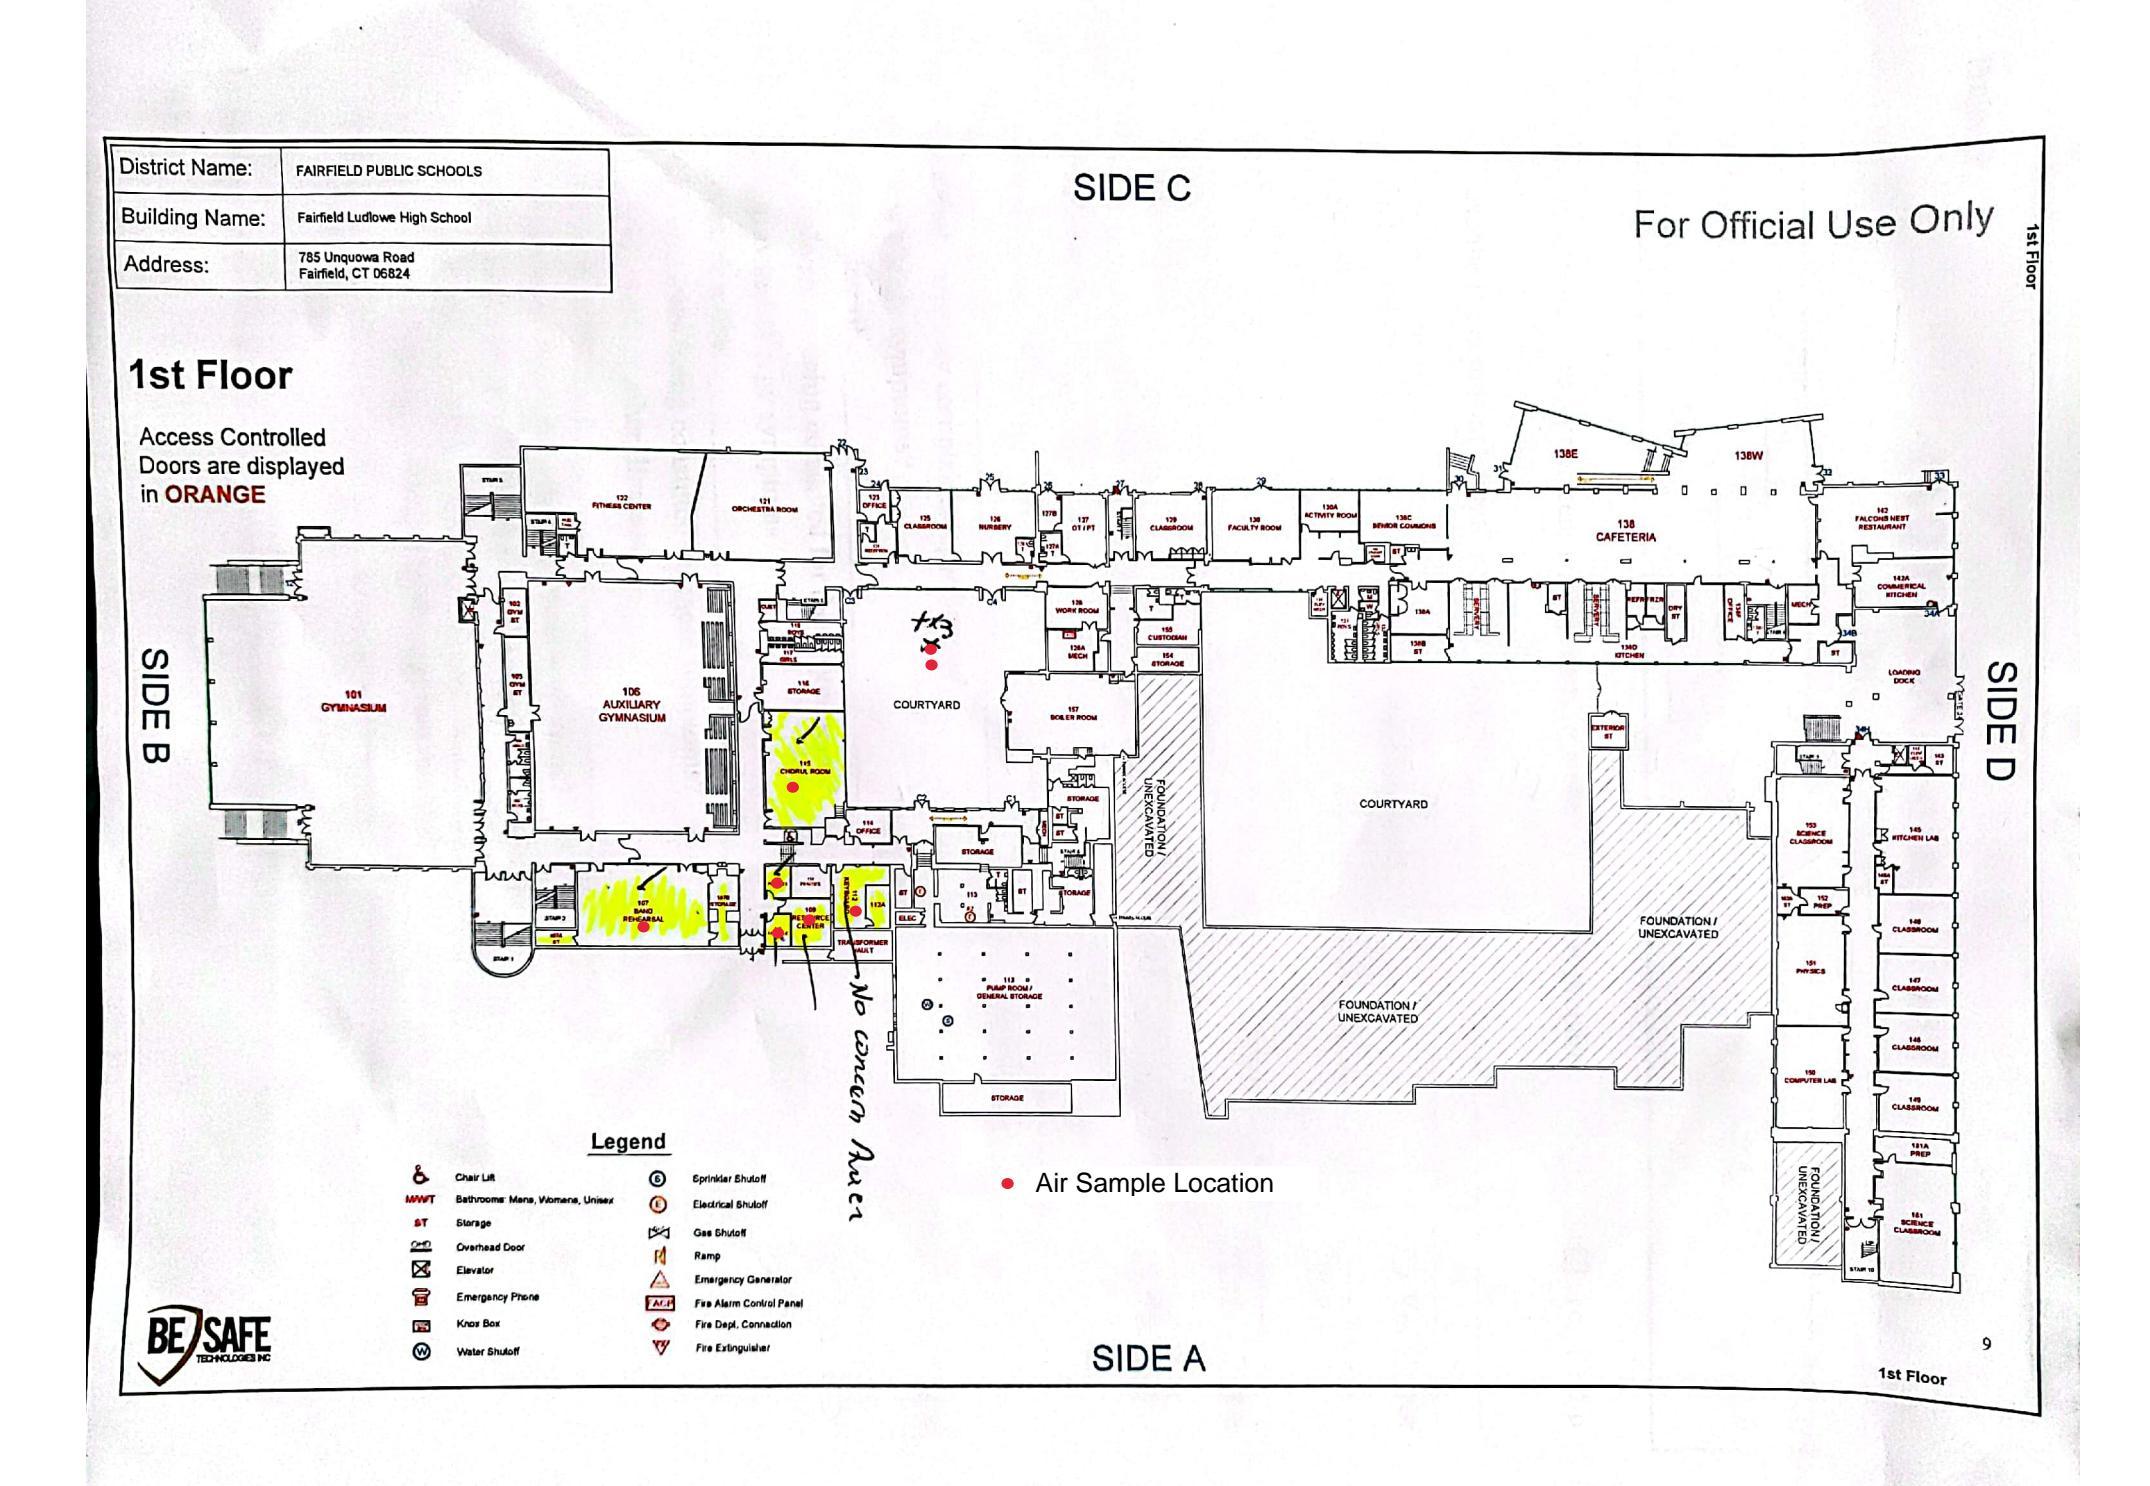
Site Diagram

Based in information provided by the Client, a faculty member has expressed concerns related to indoor air quality in room 107. The Client also requested rooms 108, 109, 110, 115 be included in the assessment as areas of concern. Room 112 (non-complaint area) was also evaluated for comparison purposes. Refer to *Appendix B* for the site diagram.

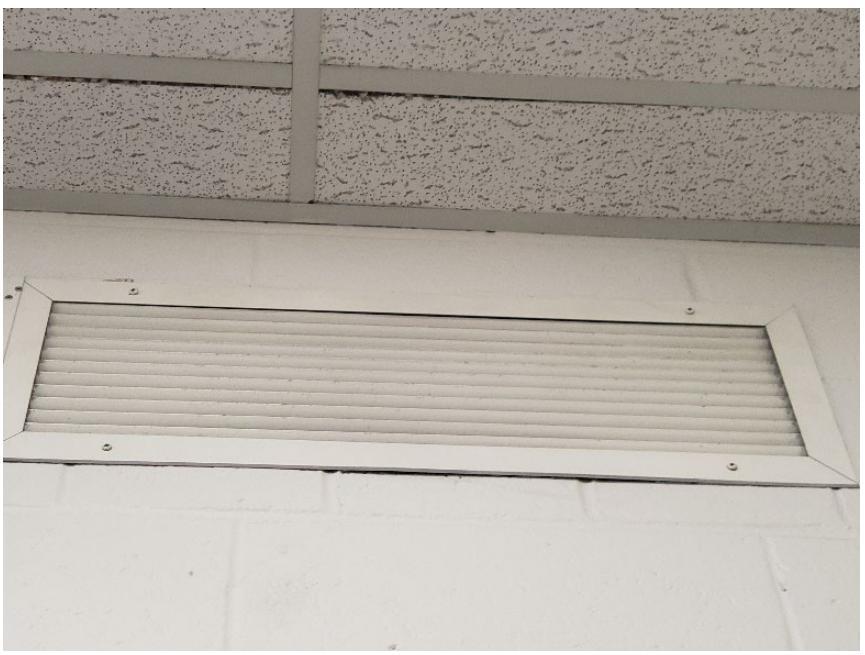
- Supply diffusers and return grates displayed evidence of dust accumulation
- Room 108
 - Suspect mold growth observed on fabric wall paneling behind the door

HVAC Vent with Dust Accumulation

- Conduct targeted surface cleaning to remove identified surface growth on the fabric wall panel behind the door Room 108.
 - This work should be performed in a controlled manor by qualified professionals to prevent the potential migration of mold spores during the remediation process.
- Visually review fabric wall panels throughout the school and conduct surface cleaning as needed,
 - This may include targeted review of areas that receive minimal air flow (e.g. areas behind doors, cabinets, desks, etc.)
- Generate a plan to conduct surface cleaning of HVAC supply diffusers and return grates. General cleaning of duct vent supply/return diffusers.
- Continue regular preventative maintenance of the HVAC system, including regular filter changes/cleaning and maintenance.

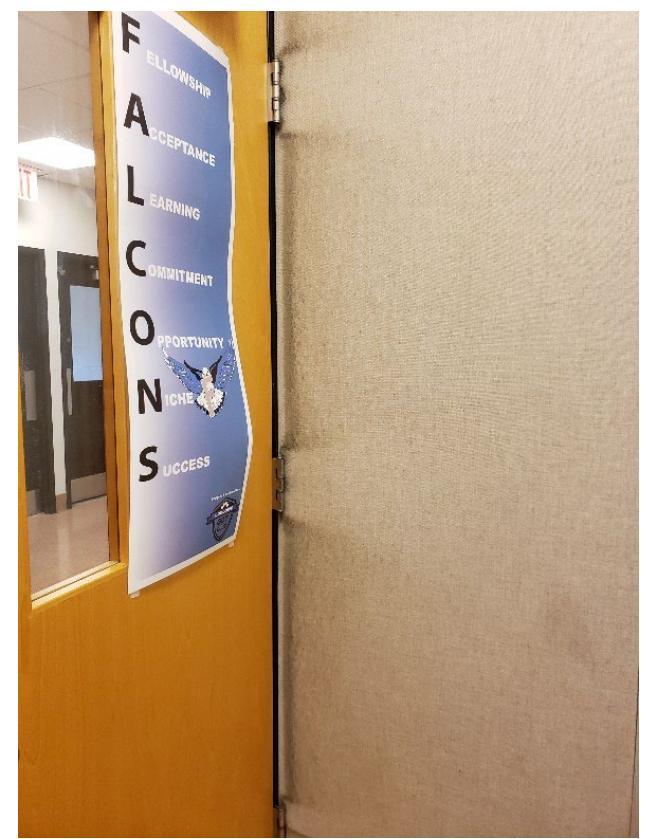
The results of the swab samples collected from representative areas of suspect mold growth observed on wall paneling in room 108 (behind the door) identified the spore type *Cladosporium* in low counts. This spore type was identified in the air sample collected from this area in minimal concentrations. This spore type was also observed in the exterior ambient samples in similar concentrations.

At the time of the assessment, minimal moisture concentrations were detected on the wall paneling in room 108 where suspected mold growth was observed and in room 112 where the ceiling tile was observed to be water stained. These measurements indicate an active moisture source was not present in these areas at the time of the assessment.

Room 108 Suspect Mold Growth observed at the Wall Paneling Behind the Door

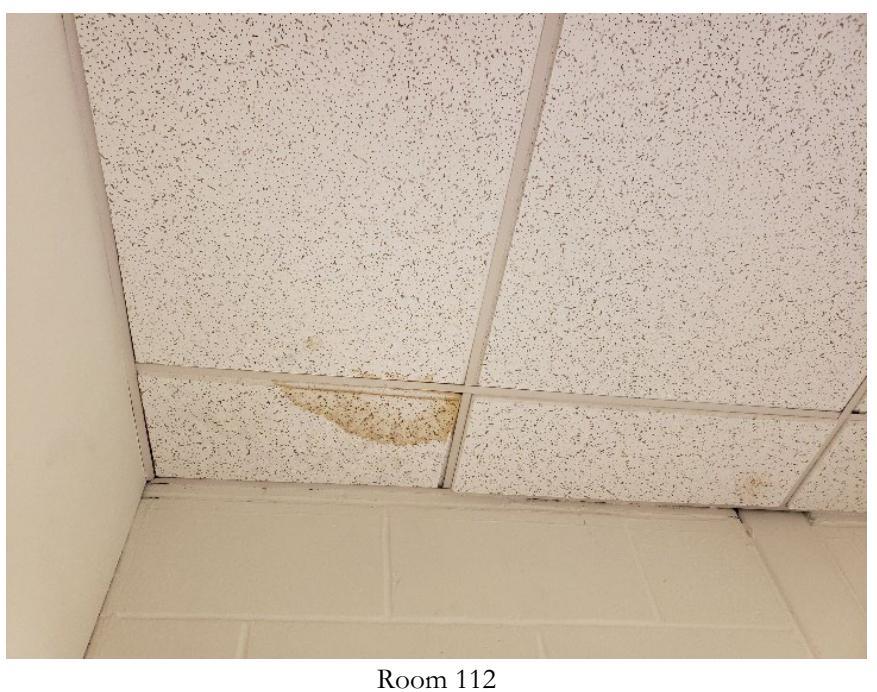
- Water staining observed on one of the suspended ceiling tiles.
 - Elevated moisture content was not identified in the area of suspect mold growth

Water Staining observed on one of the Suspended Ceiling Tiles
